Map 9-2
Location of Selected Former Industrial Operations
Supplemental Remedial Investigation
East Waterway Operable Unit

Map 9-7
Listed Sites Reported within EW Combined Sewer and Inland Storm Drainage Basins
Supplemental Remedial Investigation
East Waterway Operable Unit

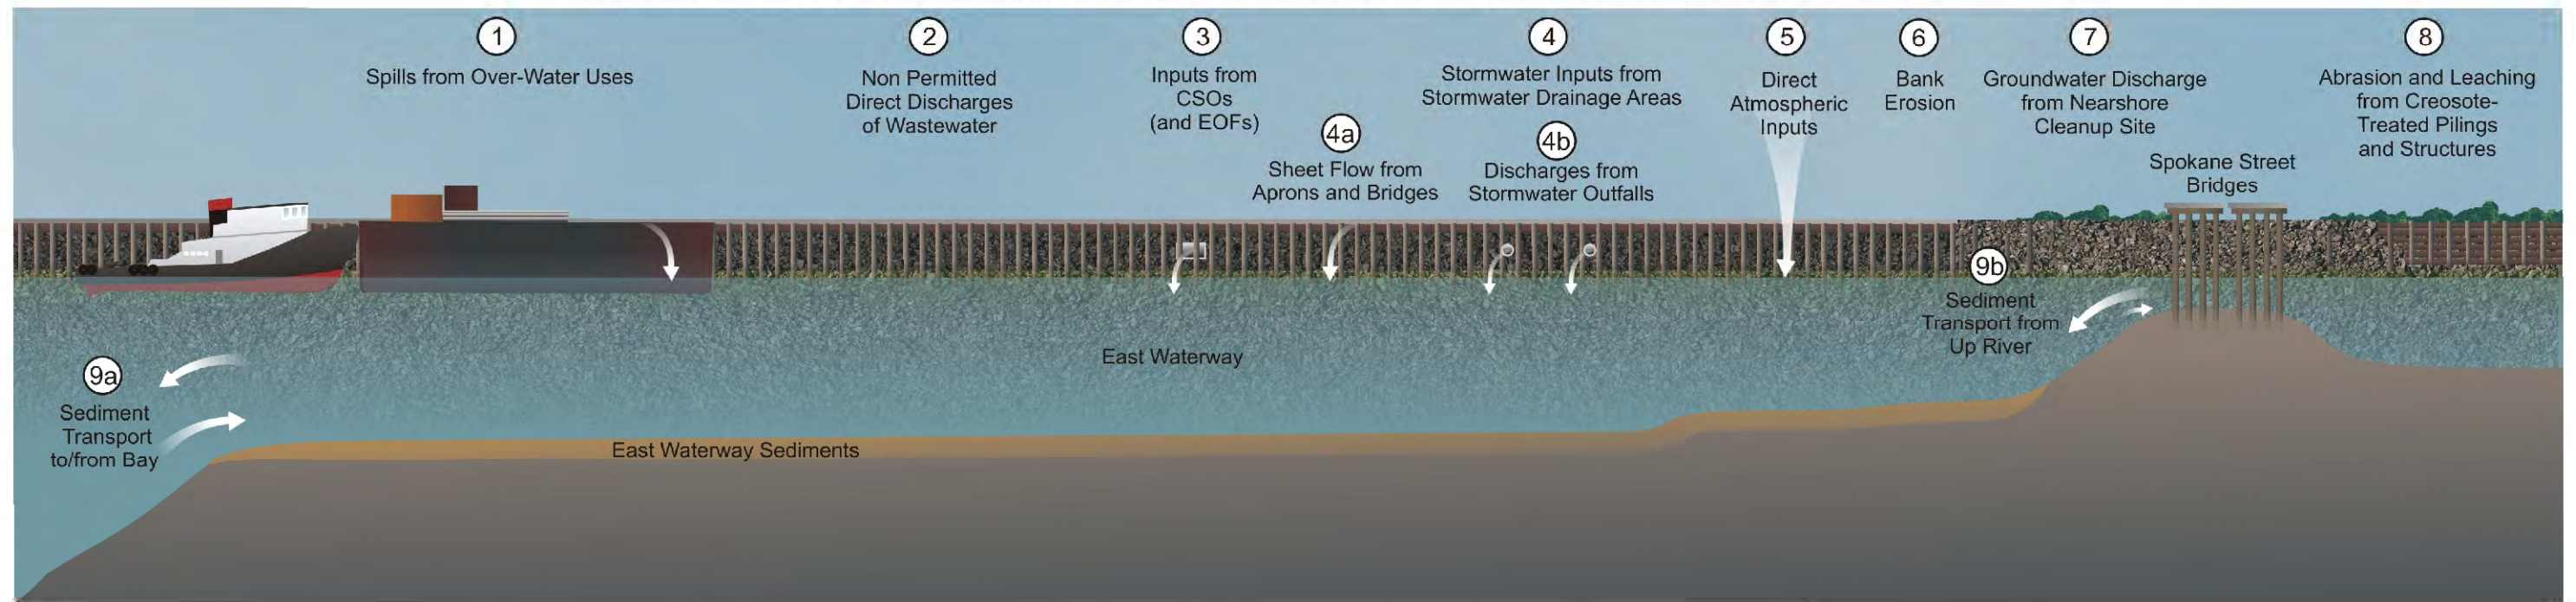
Direct Pathways Considered as Part of East Waterway Source Control Evaluation

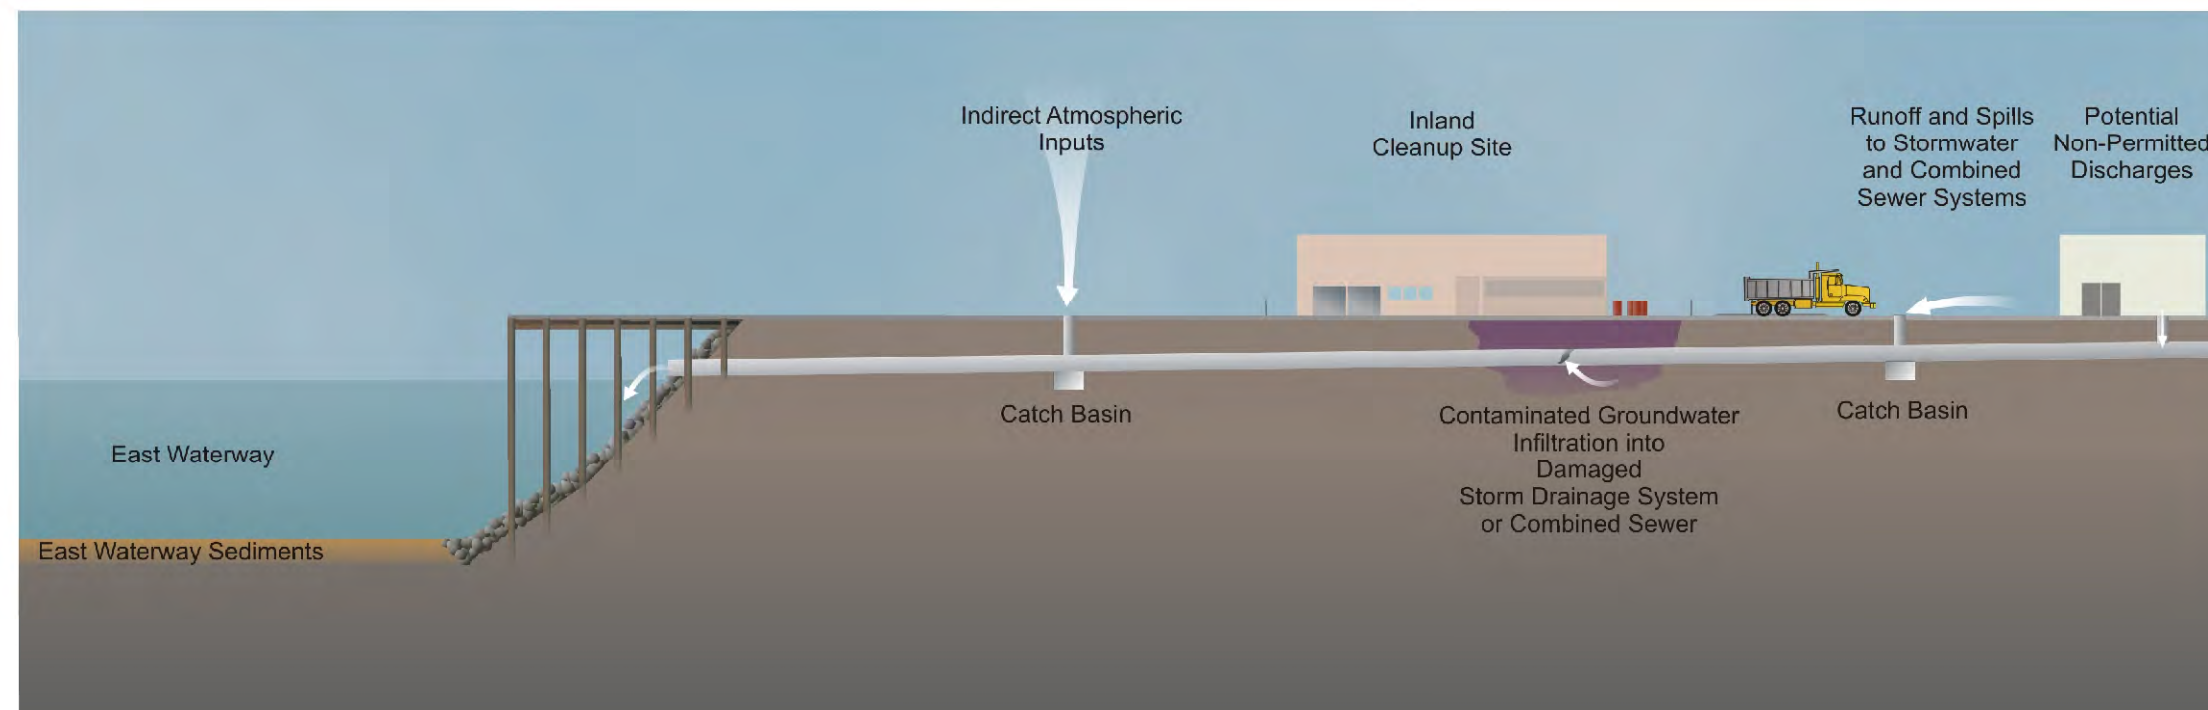
Indirect Pathways Potentially Contributing to CSO and Stormwater Pathways

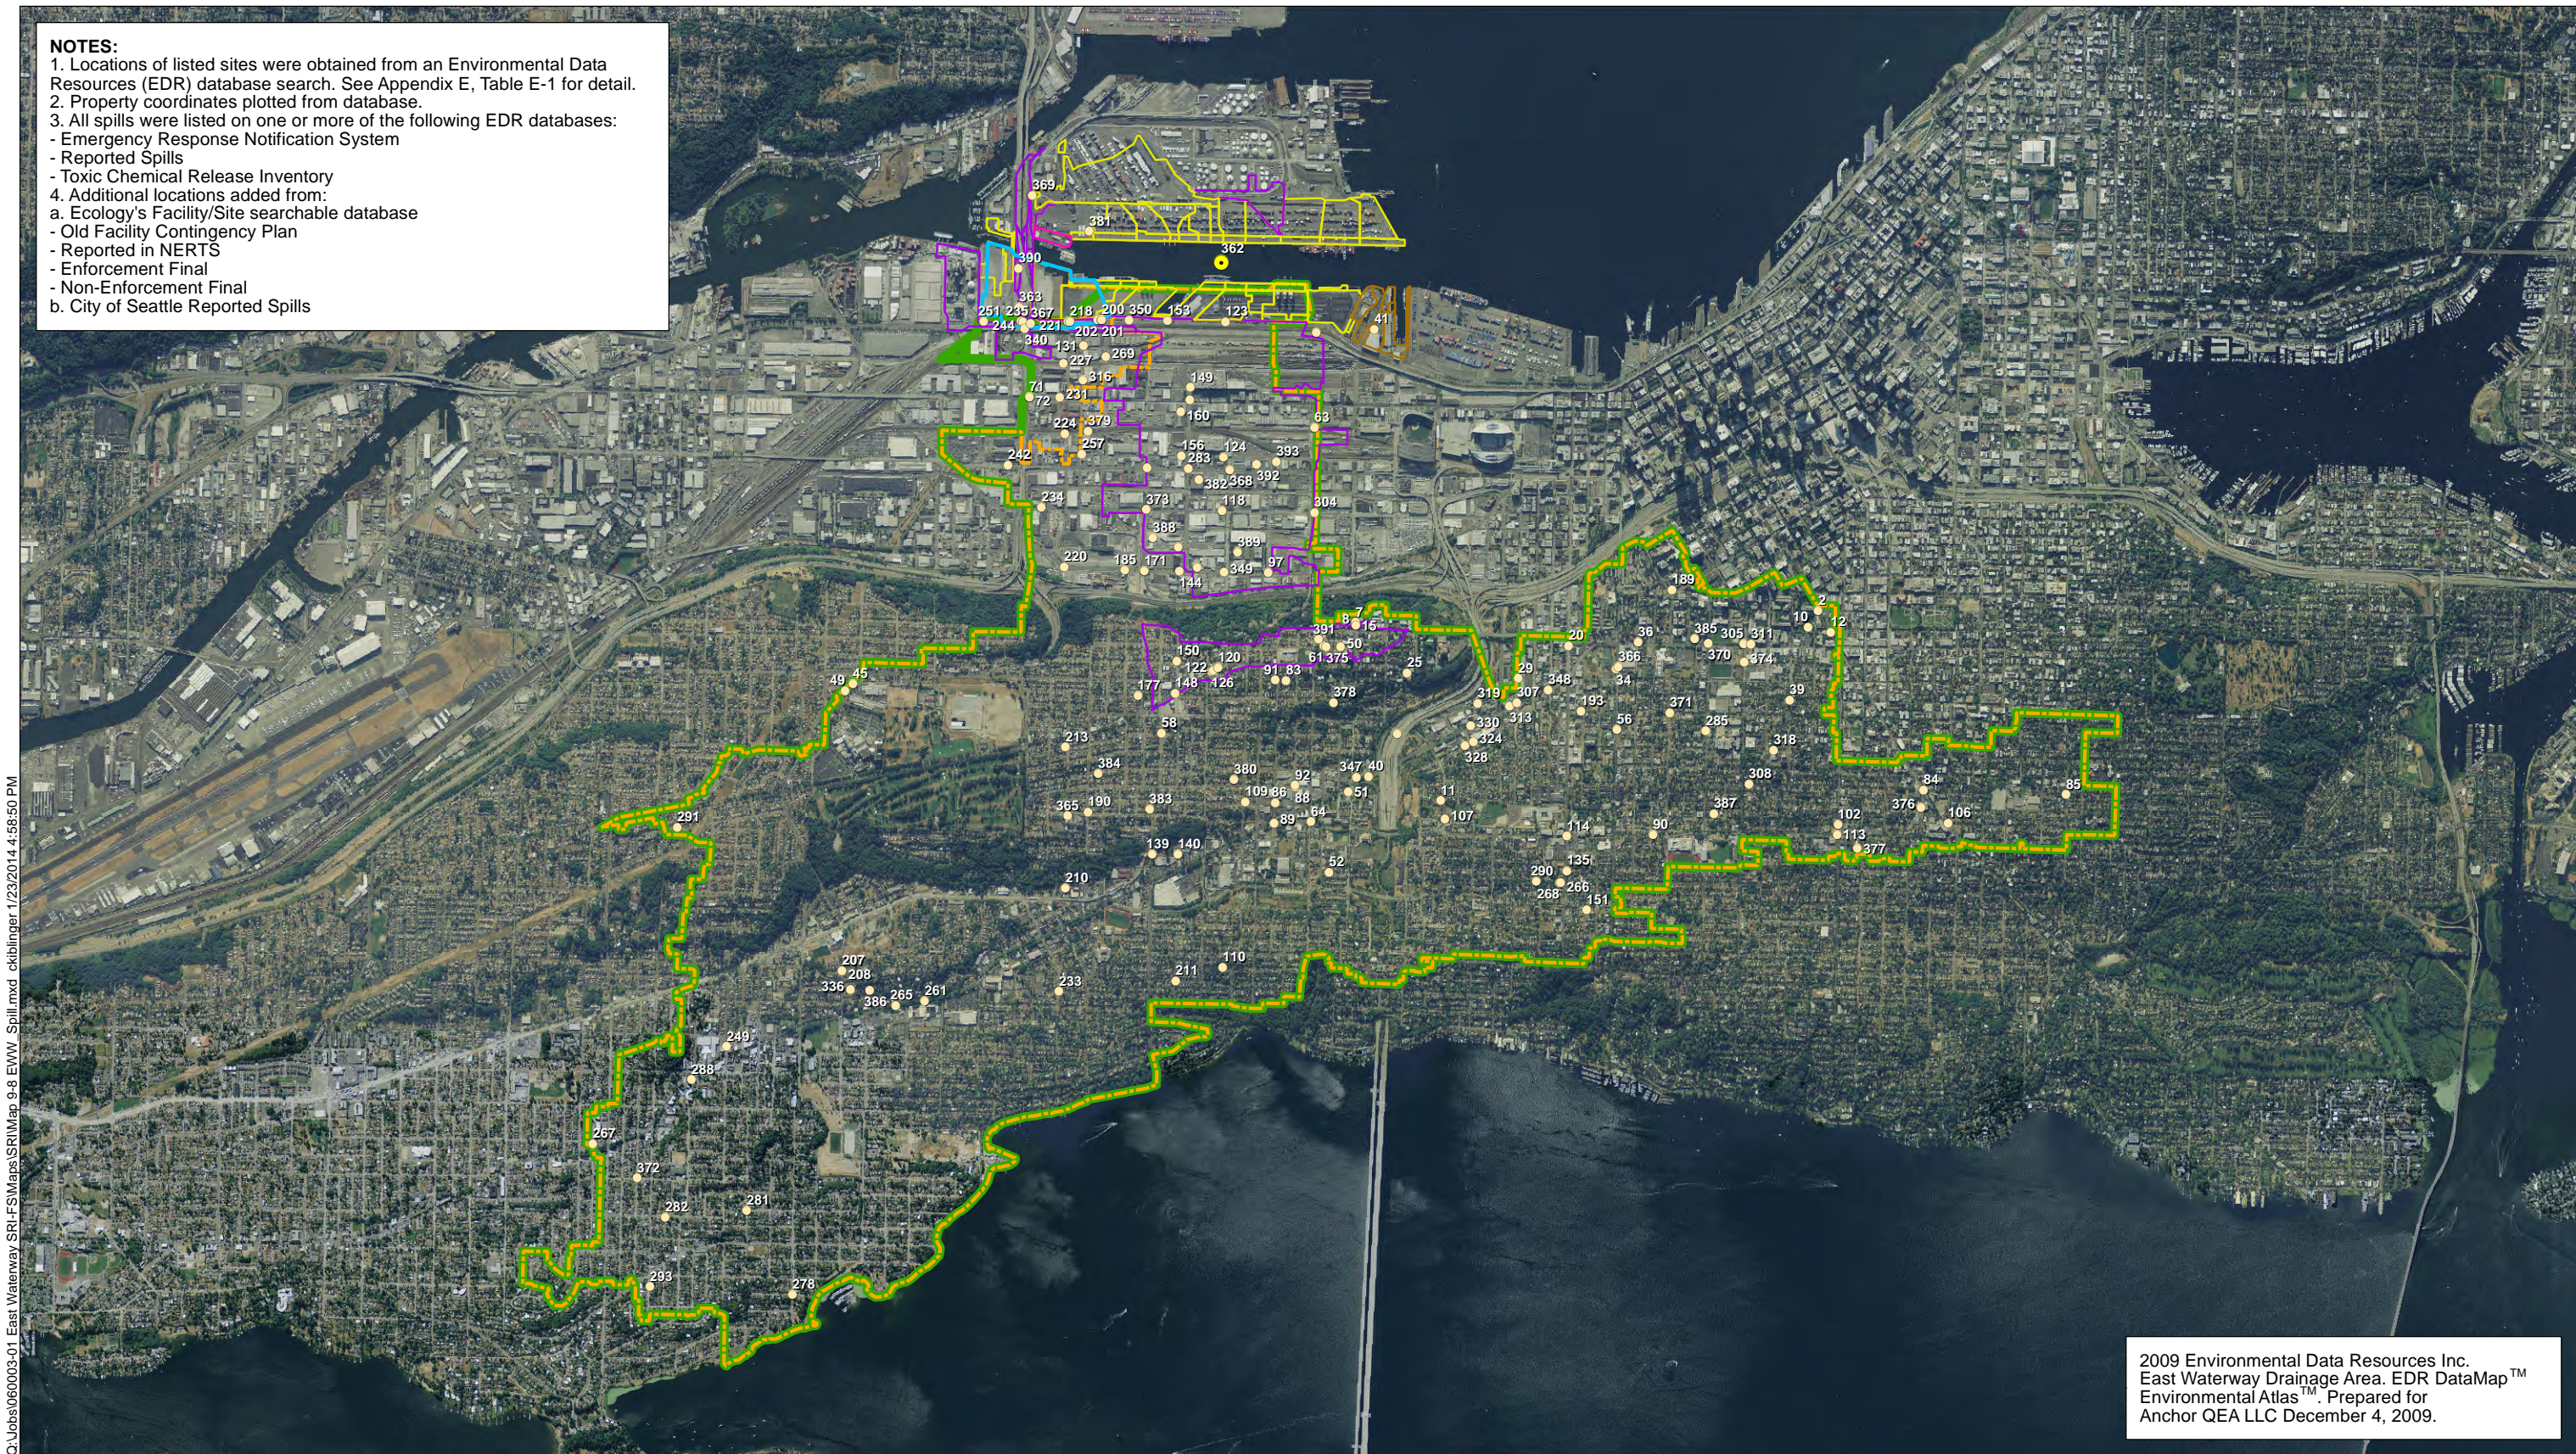
Map 9-8
Reported Spill Sites
Supplemental Remedial Investigation
East Waterway Operable Unit

- Spill Site
- Spills Directly to East Waterway

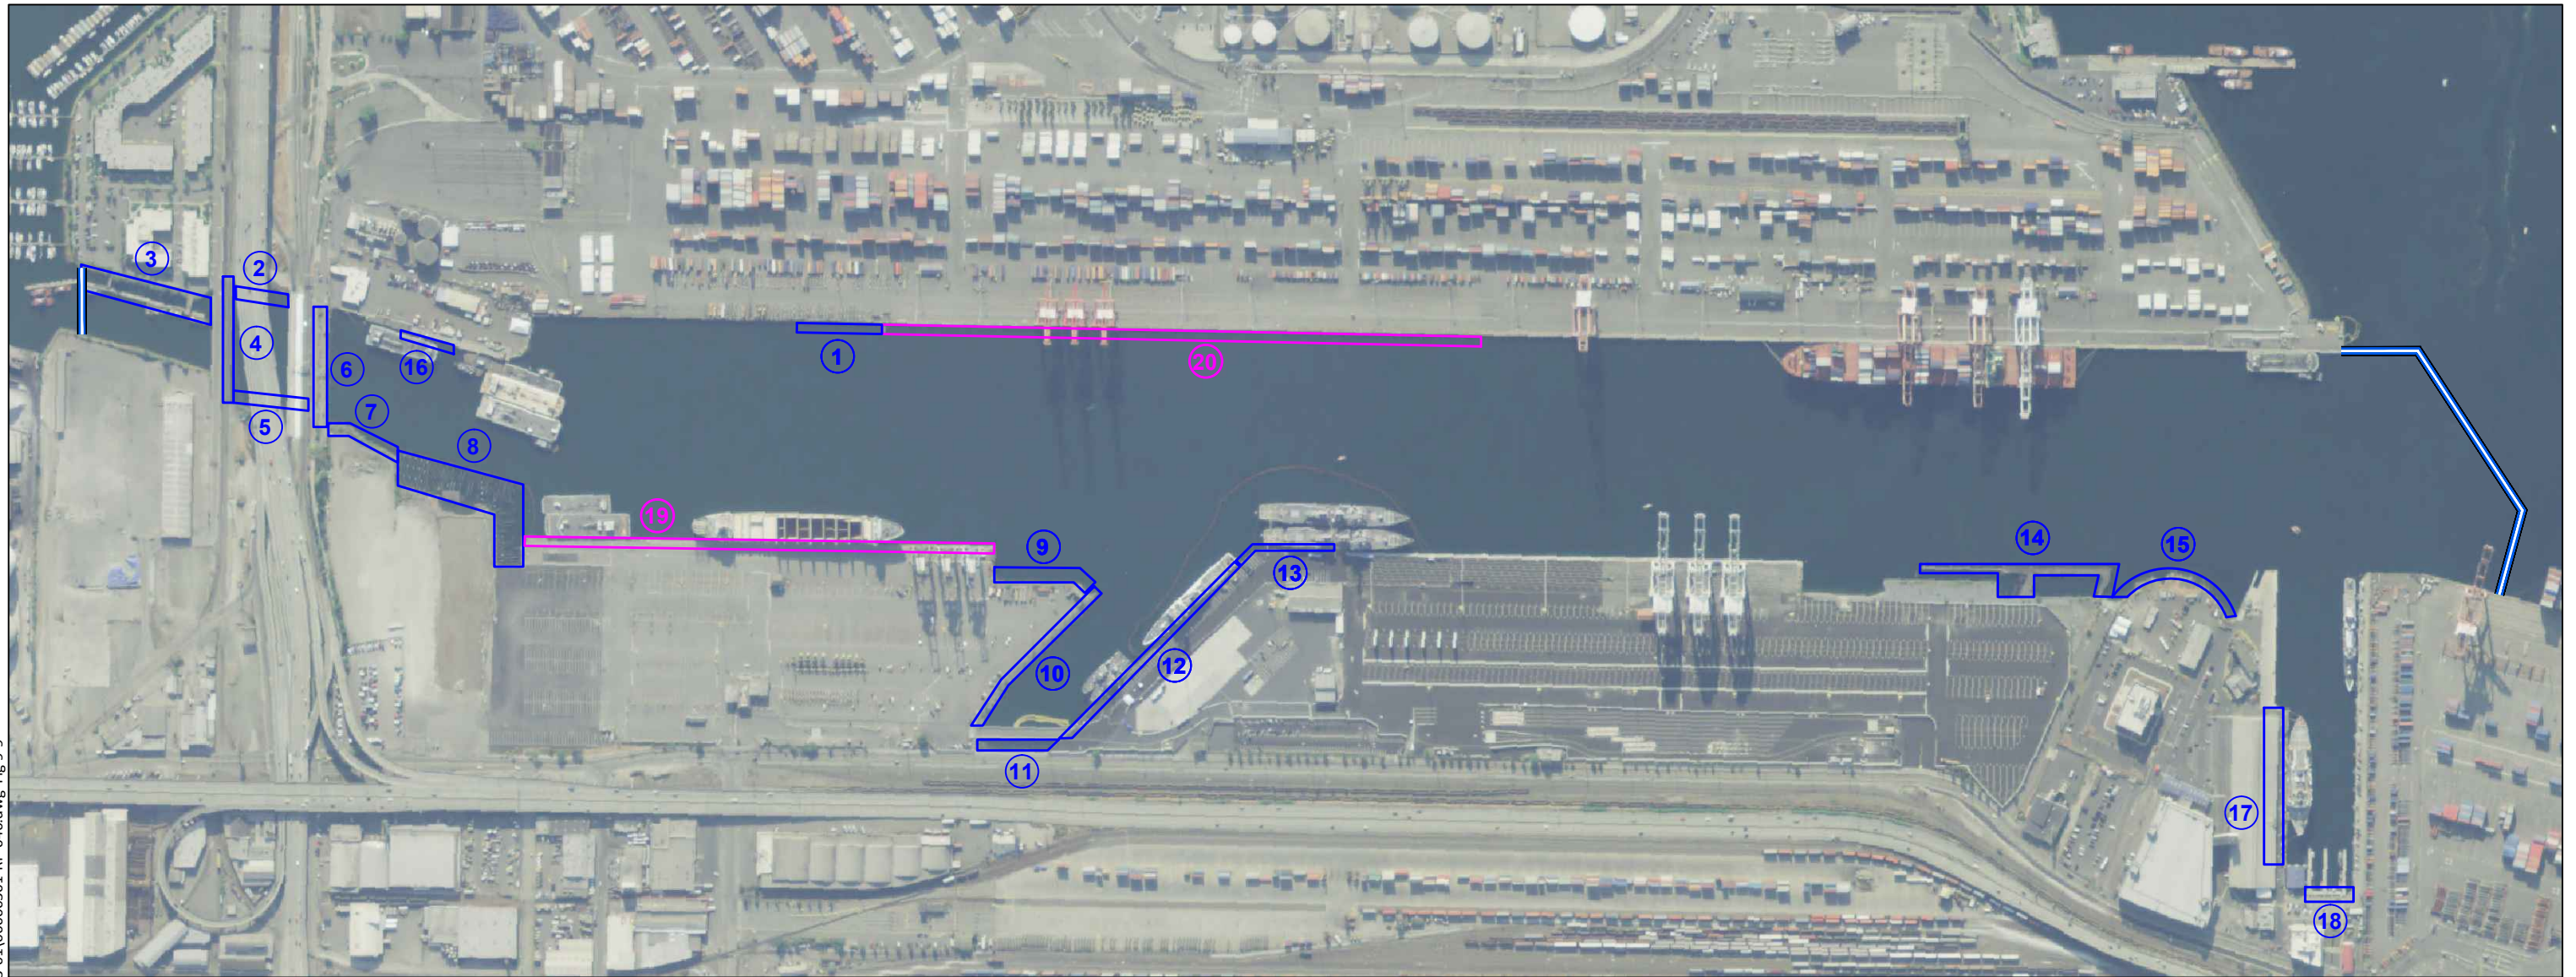
Map 9-9
Current Location of Creosote and CCA Treated Structures
Supplemental Remedial Investigation
East Waterway Operable Unit

Creosoted Bulkheads, Pile and Fender Pile Areas:

Chromated Copper Arsenate (CCA) Pile and Fender Pile Areas⁵:

- NOTES:**
1. Stub Pile: Pile that extends 3 feet or less above the surface.
 2. Pile counts based on visual observations made at low tide on 5/27/2010. Pile counts approximate (+/- 10%).
 3. Pipe rack and dock structure pile counts approximate (+/- 20%).
 4. Coast Guard area inspected on 6/8/2010.
 5. Terminal 18 Pile Counts updated on 1/9/12 based on Port improvements.
 6. Fender Pile: Non-structural protective mooring piling.

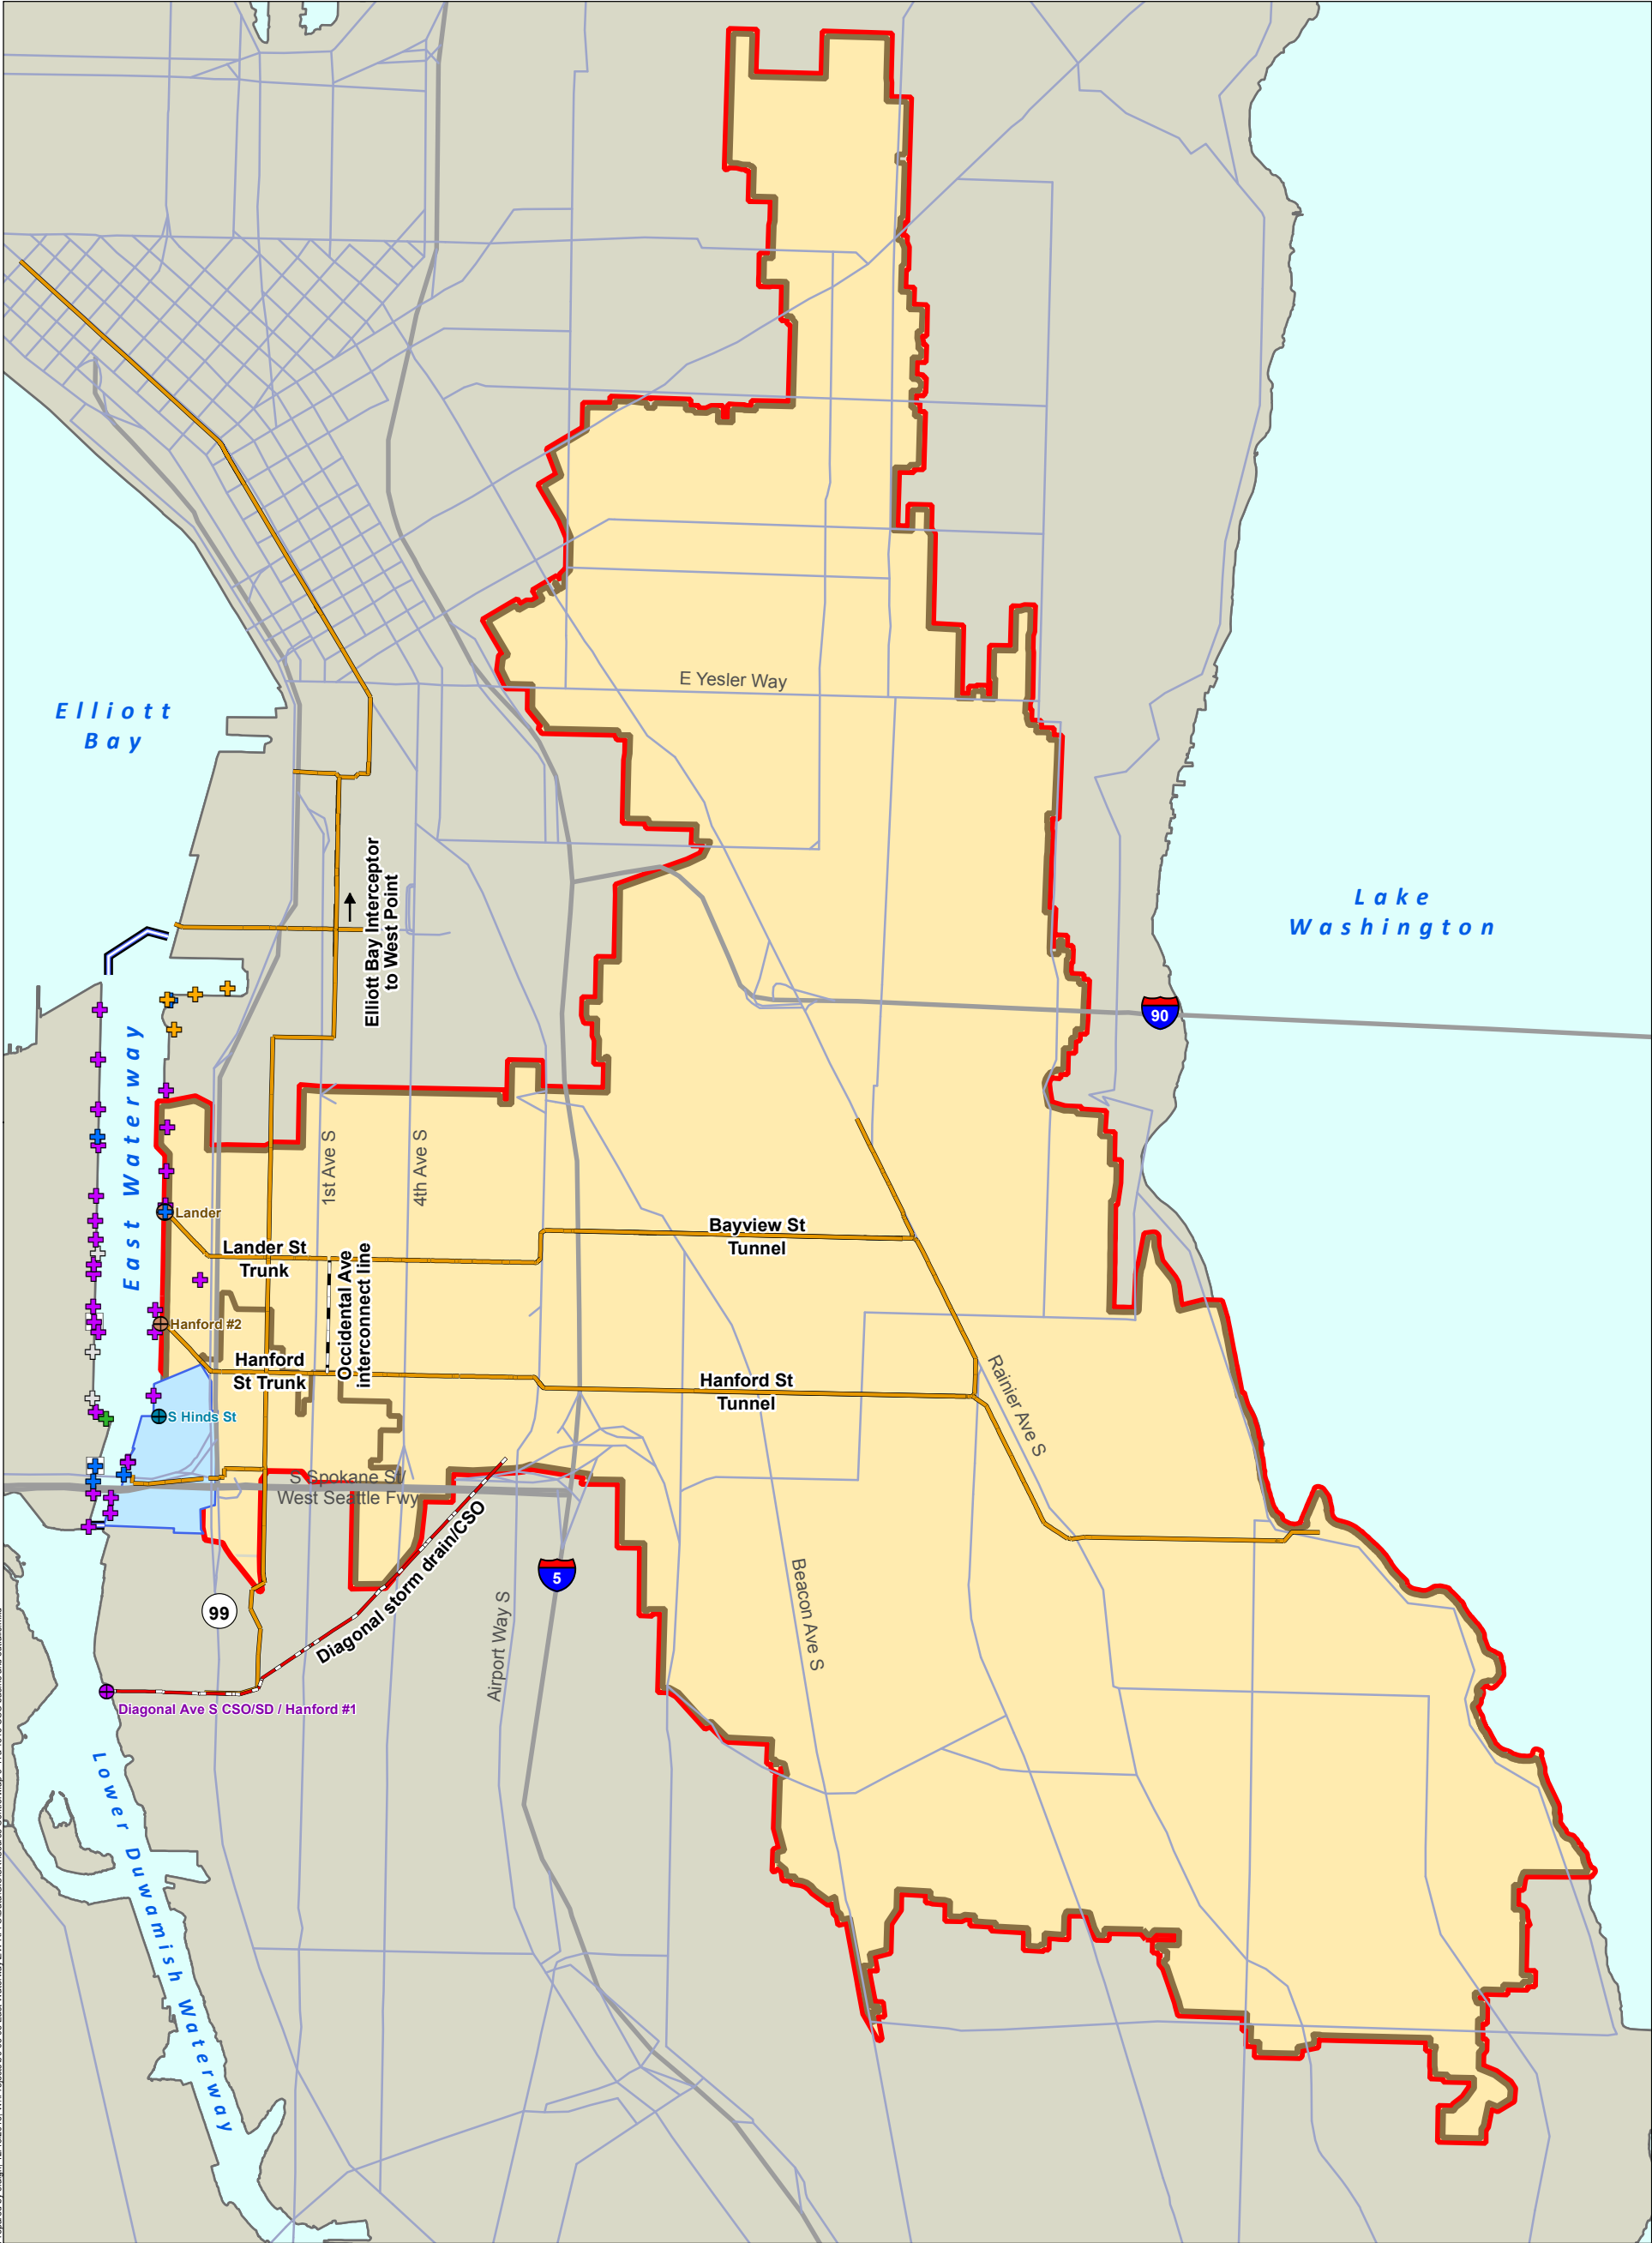
Map 9-11a
EW CSO Basins and Outfalls
Supplemental Remedial Investigation
East Waterway Study Area

¹ Source: City of Seattle. The City's Hinds CSO discharges to the Hinds CSO/SD outfall owned by the City of Seattle.
² Source: King County. The Lander and Hanford No. 2 CSO basins are largely coincident. The Lander CSO discharges to a CSO/SD outfall owned by King County; the City is responsible for operating and maintaining the separated SD system. The Hanford No. 2 CSO discharges to a CSO outfall owned by King County.
Note: Service area boundaries have not been completely validated.

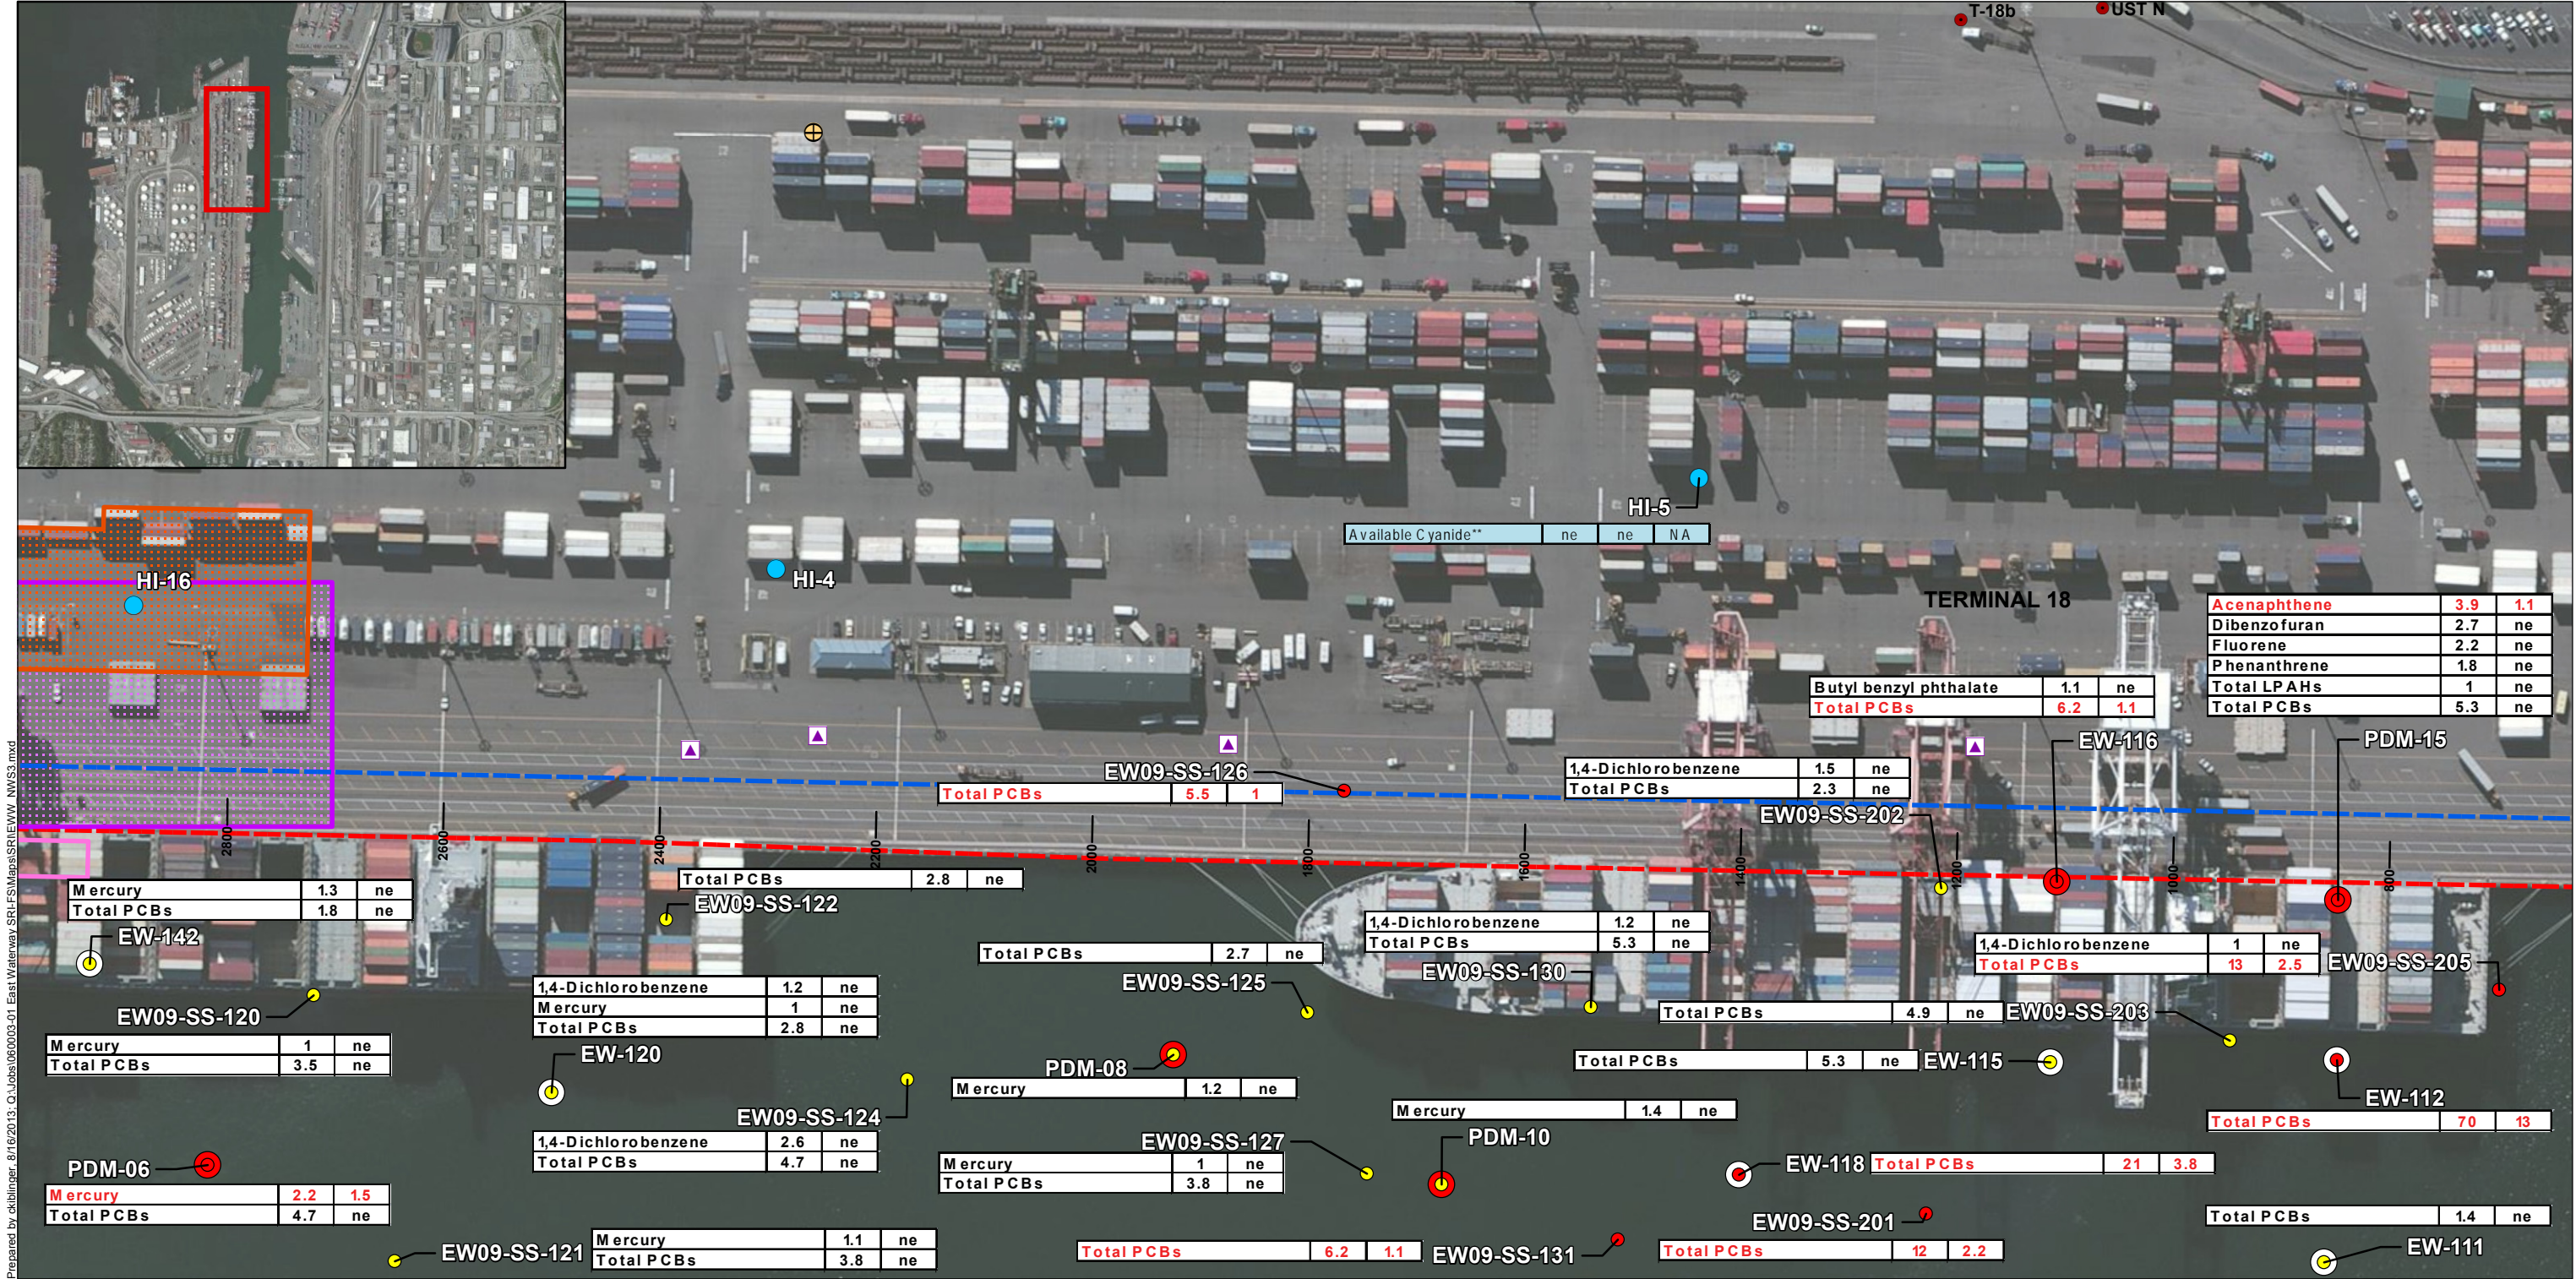
Map 9-21
Northern Harbor Island Nearshore Cleanup Site
Supplemental Remedial Investigation
East Waterway Study Area

Sediment Analyte	Sediment Exceedance Factor	
	SQS	CSL
PCBs	15	2.8

Groundwater Analyte	Groundwater Exceedance Factor		
	AWQC		Sediment Reference Value
	Chronic	Acute	
Arsenic	5	2.6	6.5

1. Values in red exceeded the Groundwater Reference Values and/or Ambient Water Quality Criteria (AWQC)
2. The EF has no regulatory significance and is presented here to provide an indication of the general magnitude of the concentration
3. ne = not exceeded
4. Only maximum EF is shown, if applicable
5. Evaluated groundwater data is presented in Appendix J
6. NA = not applicable

1. "Compliance" is defined for the purposes of this report as wells closest to the East Waterway and does not reflect any well designations based on the Harbor Island Soil and Groundwater OU or related reports and agreements.
2. "Inland" is defined for the purposes of this report as wells farther away from the East Waterway shoreline.
3. Sources for these investigations are presented in Section 9 and results are presented in Appendix J.
4. For more detailed piling information see Map 9-9.

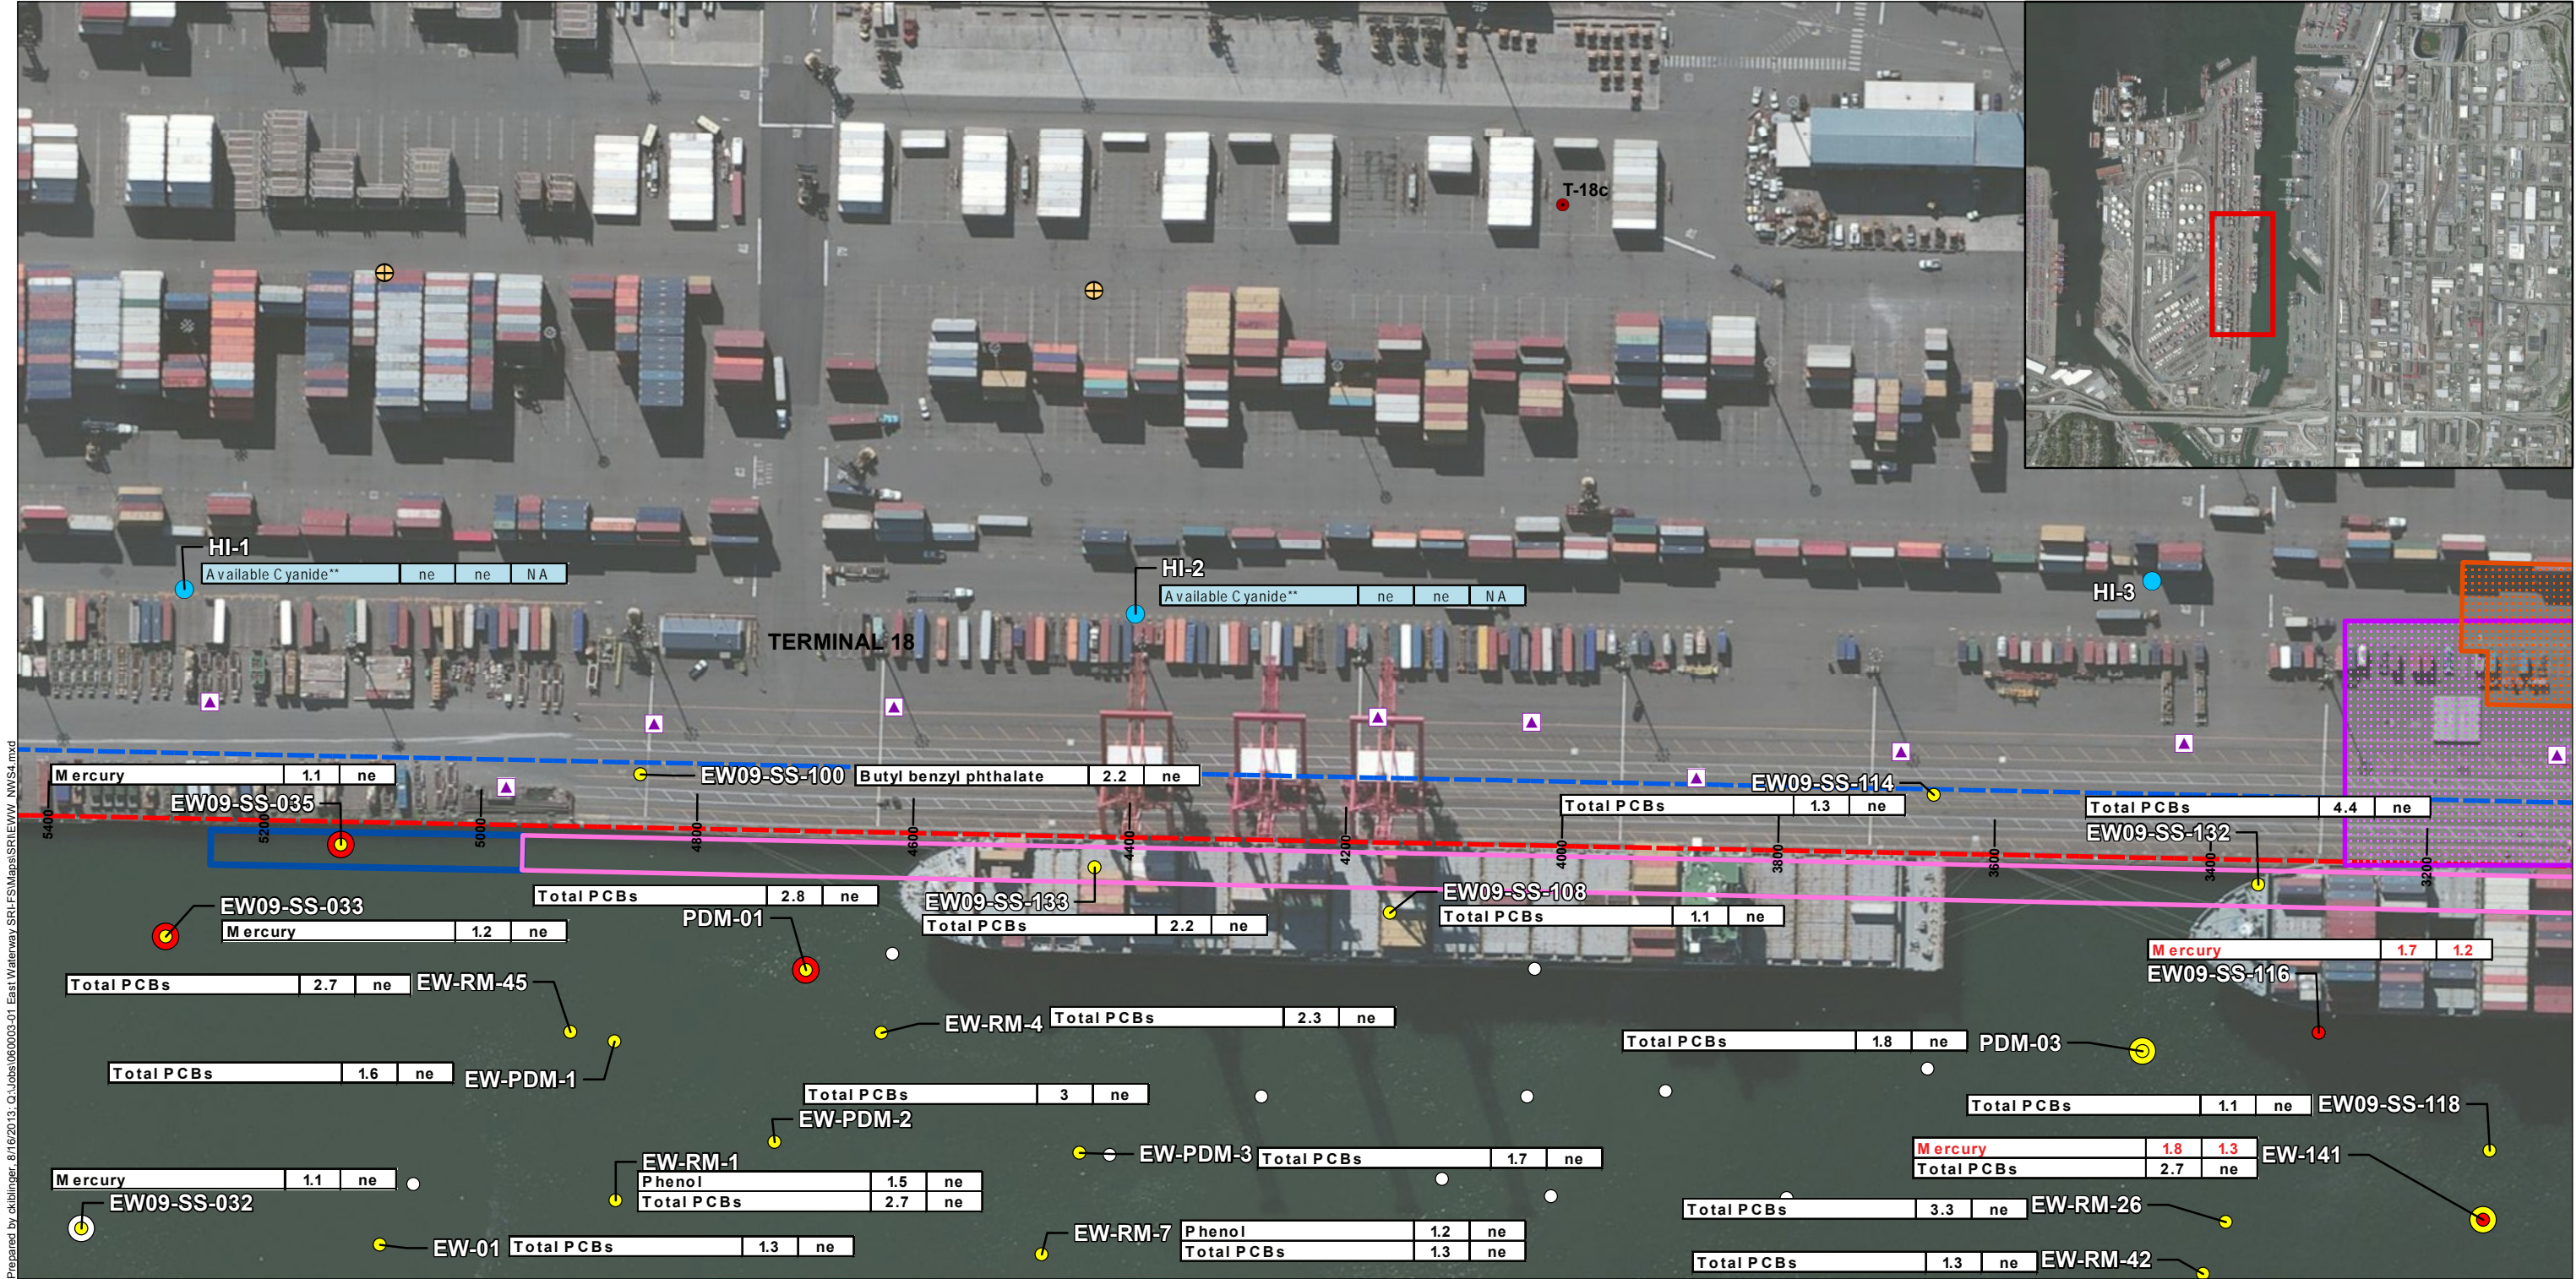
Map 9-22
Middle Harbor Island Nearshore Cleanup Site
Supplemental Remedial Investigation
East Waterway Study Area

Sediment Analyte	Sediment Exceedance Factor	
	SQS	CSL
PCBs	15	2.8

Groundwater Analyte	Groundwater Exceedance Factor		
	AWQC		Sediment Reference Value
	Chronic	Acute	
Arsenic	5	2.6	6.5

1. Values in red exceeded the Groundwater Reference Values and/or Ambient Water Quality Criteria (AWQC)
2. The EF has no regulatory significance and is presented here to provide an indication of the general magnitude of the concentration
3. ne = not exceeded
4. Only maximum EF is shown, if applicable
5. Evaluated groundwater data is presented in Appendix J
6. NA = not applicable

1. "Compliance" is defined for the purposes of this report as wells closest to the East Waterway and does not reflect any well designations based on the Harbor Island Soil and Groundwater OU or related reports and agreements.
2. "Inland" is defined for the purposes of this report as wells farther away from the East Waterway shoreline.
3. Sources for these investigations are presented in Section 9 and results are presented in Appendix J.
4. For more detailed piling information see Map 9-9.
