Map 9-2
Location of Selected Former Industrial Operations
Supplemental Remedial Investigation
East Waterway Operable Unit

Map 9-7
Listed Sites Reported within EW Combined Sewer and Inland Storm Drainage Basins
Supplemental Remedial Investigation
East Waterway Operable Unit

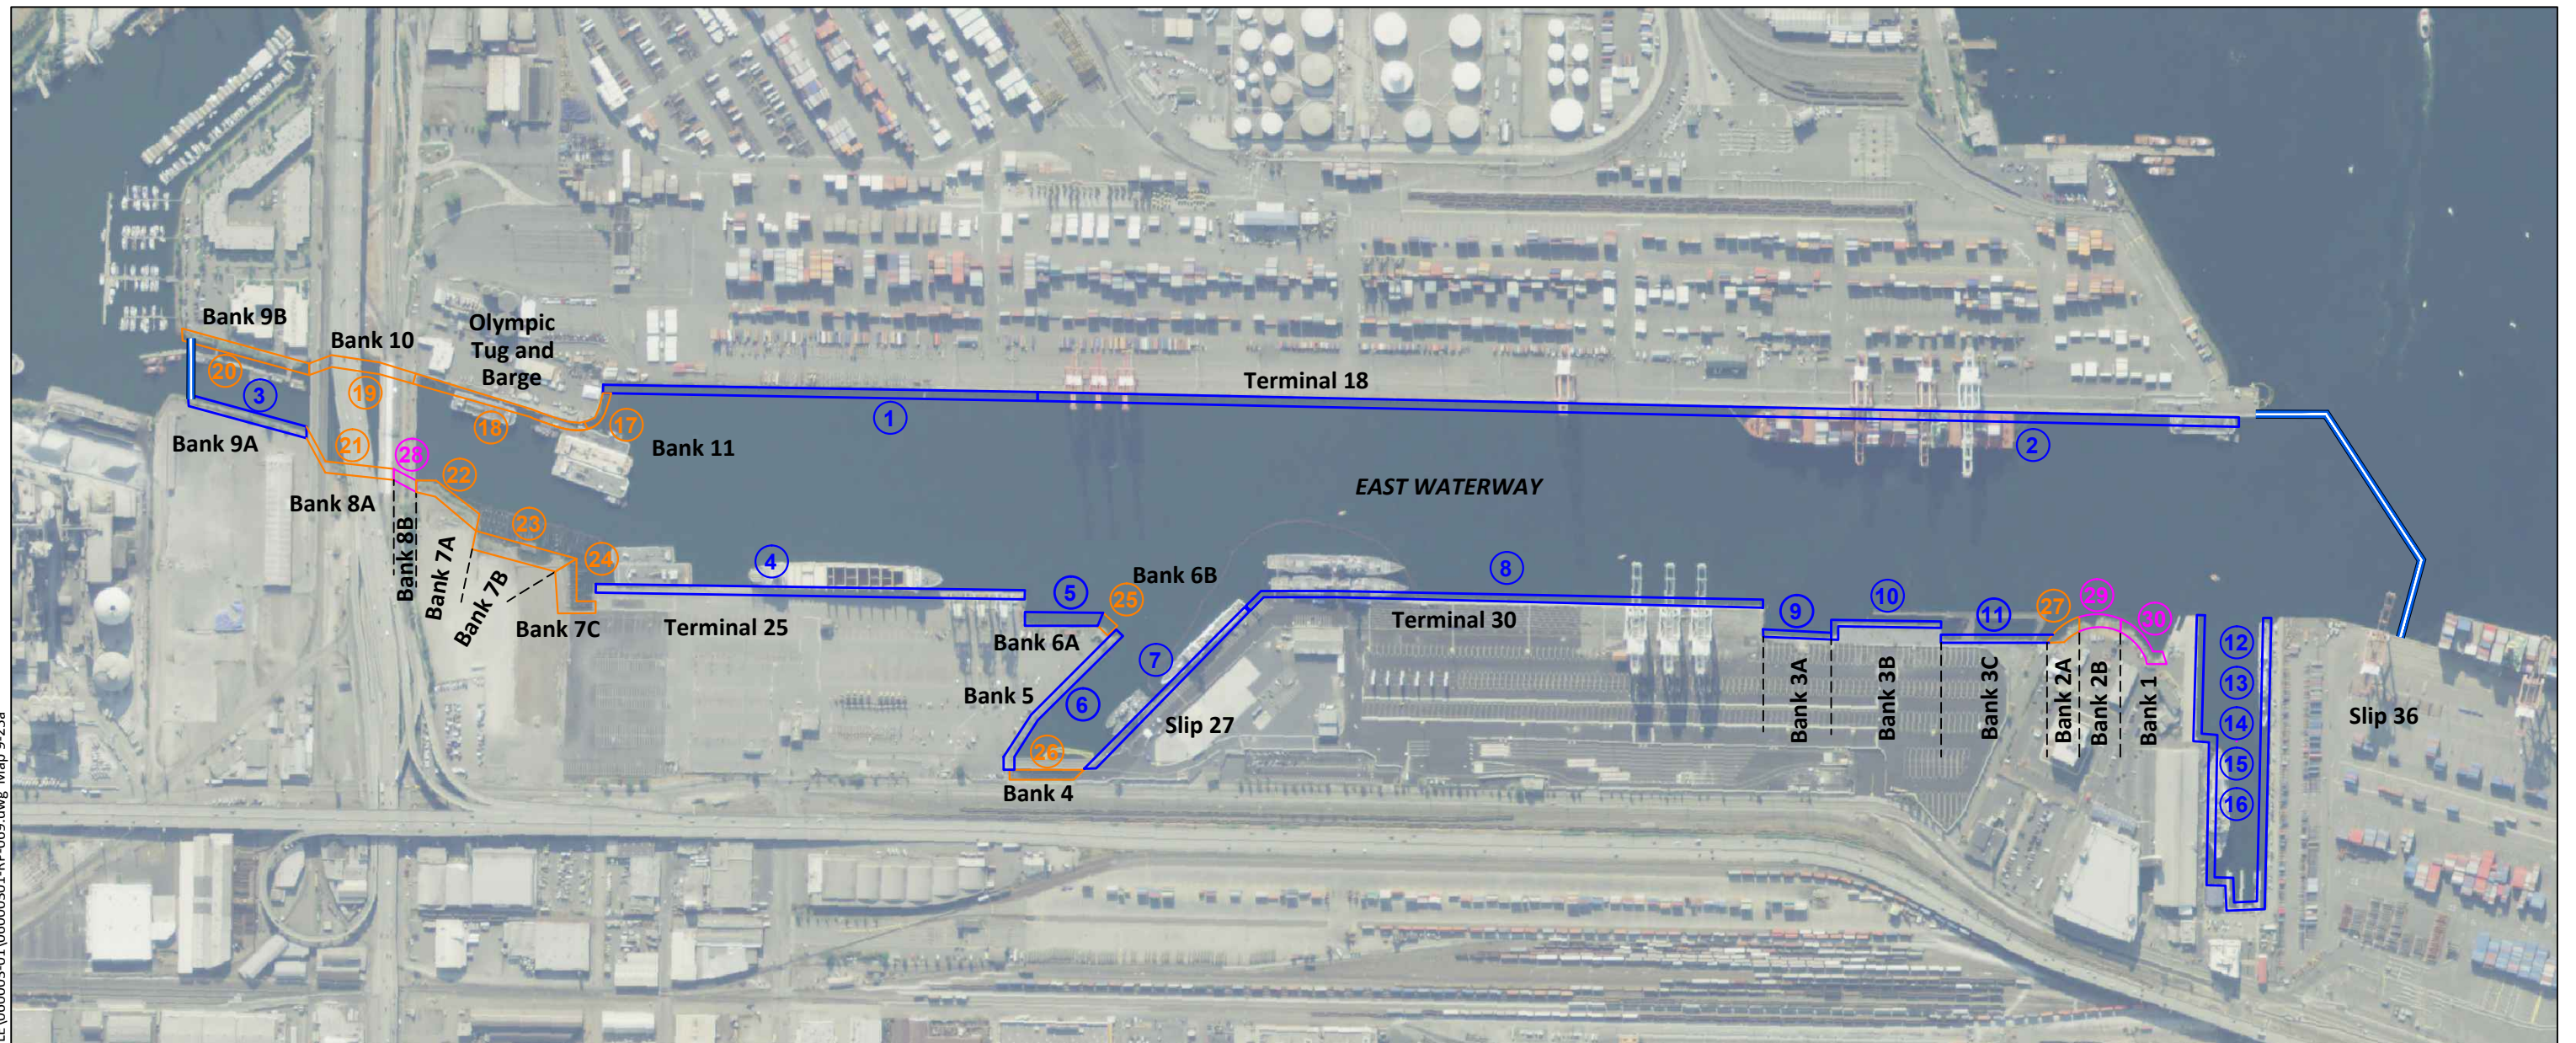
Map 9-25c
Bank Construction Types
Supplemental Remedial Investigation
East Waterway Operable Unit

Type A Engineered Bank¹

Type B Engineered Bank²

Type C Non-Engineered Bank³

1. Type A: Engineered bank with armor stone and/or metal bulkhead.
2. Type B: Engineered bank with rubble or gravel armor and/or wooden or concrete bulkhead.
3. Type C: Non-engineered rubble armored slope or non-engineered mud/gravel bank.
4. Type D: Non-engineered steep bank, higher potential for bank erosion.
