Map A.2-1. Spatial distribution of infaunal successional stages in the EW.

Map A.2-2. Sampling locations for discrete surface sediment samples and bioassay data used in the ERA

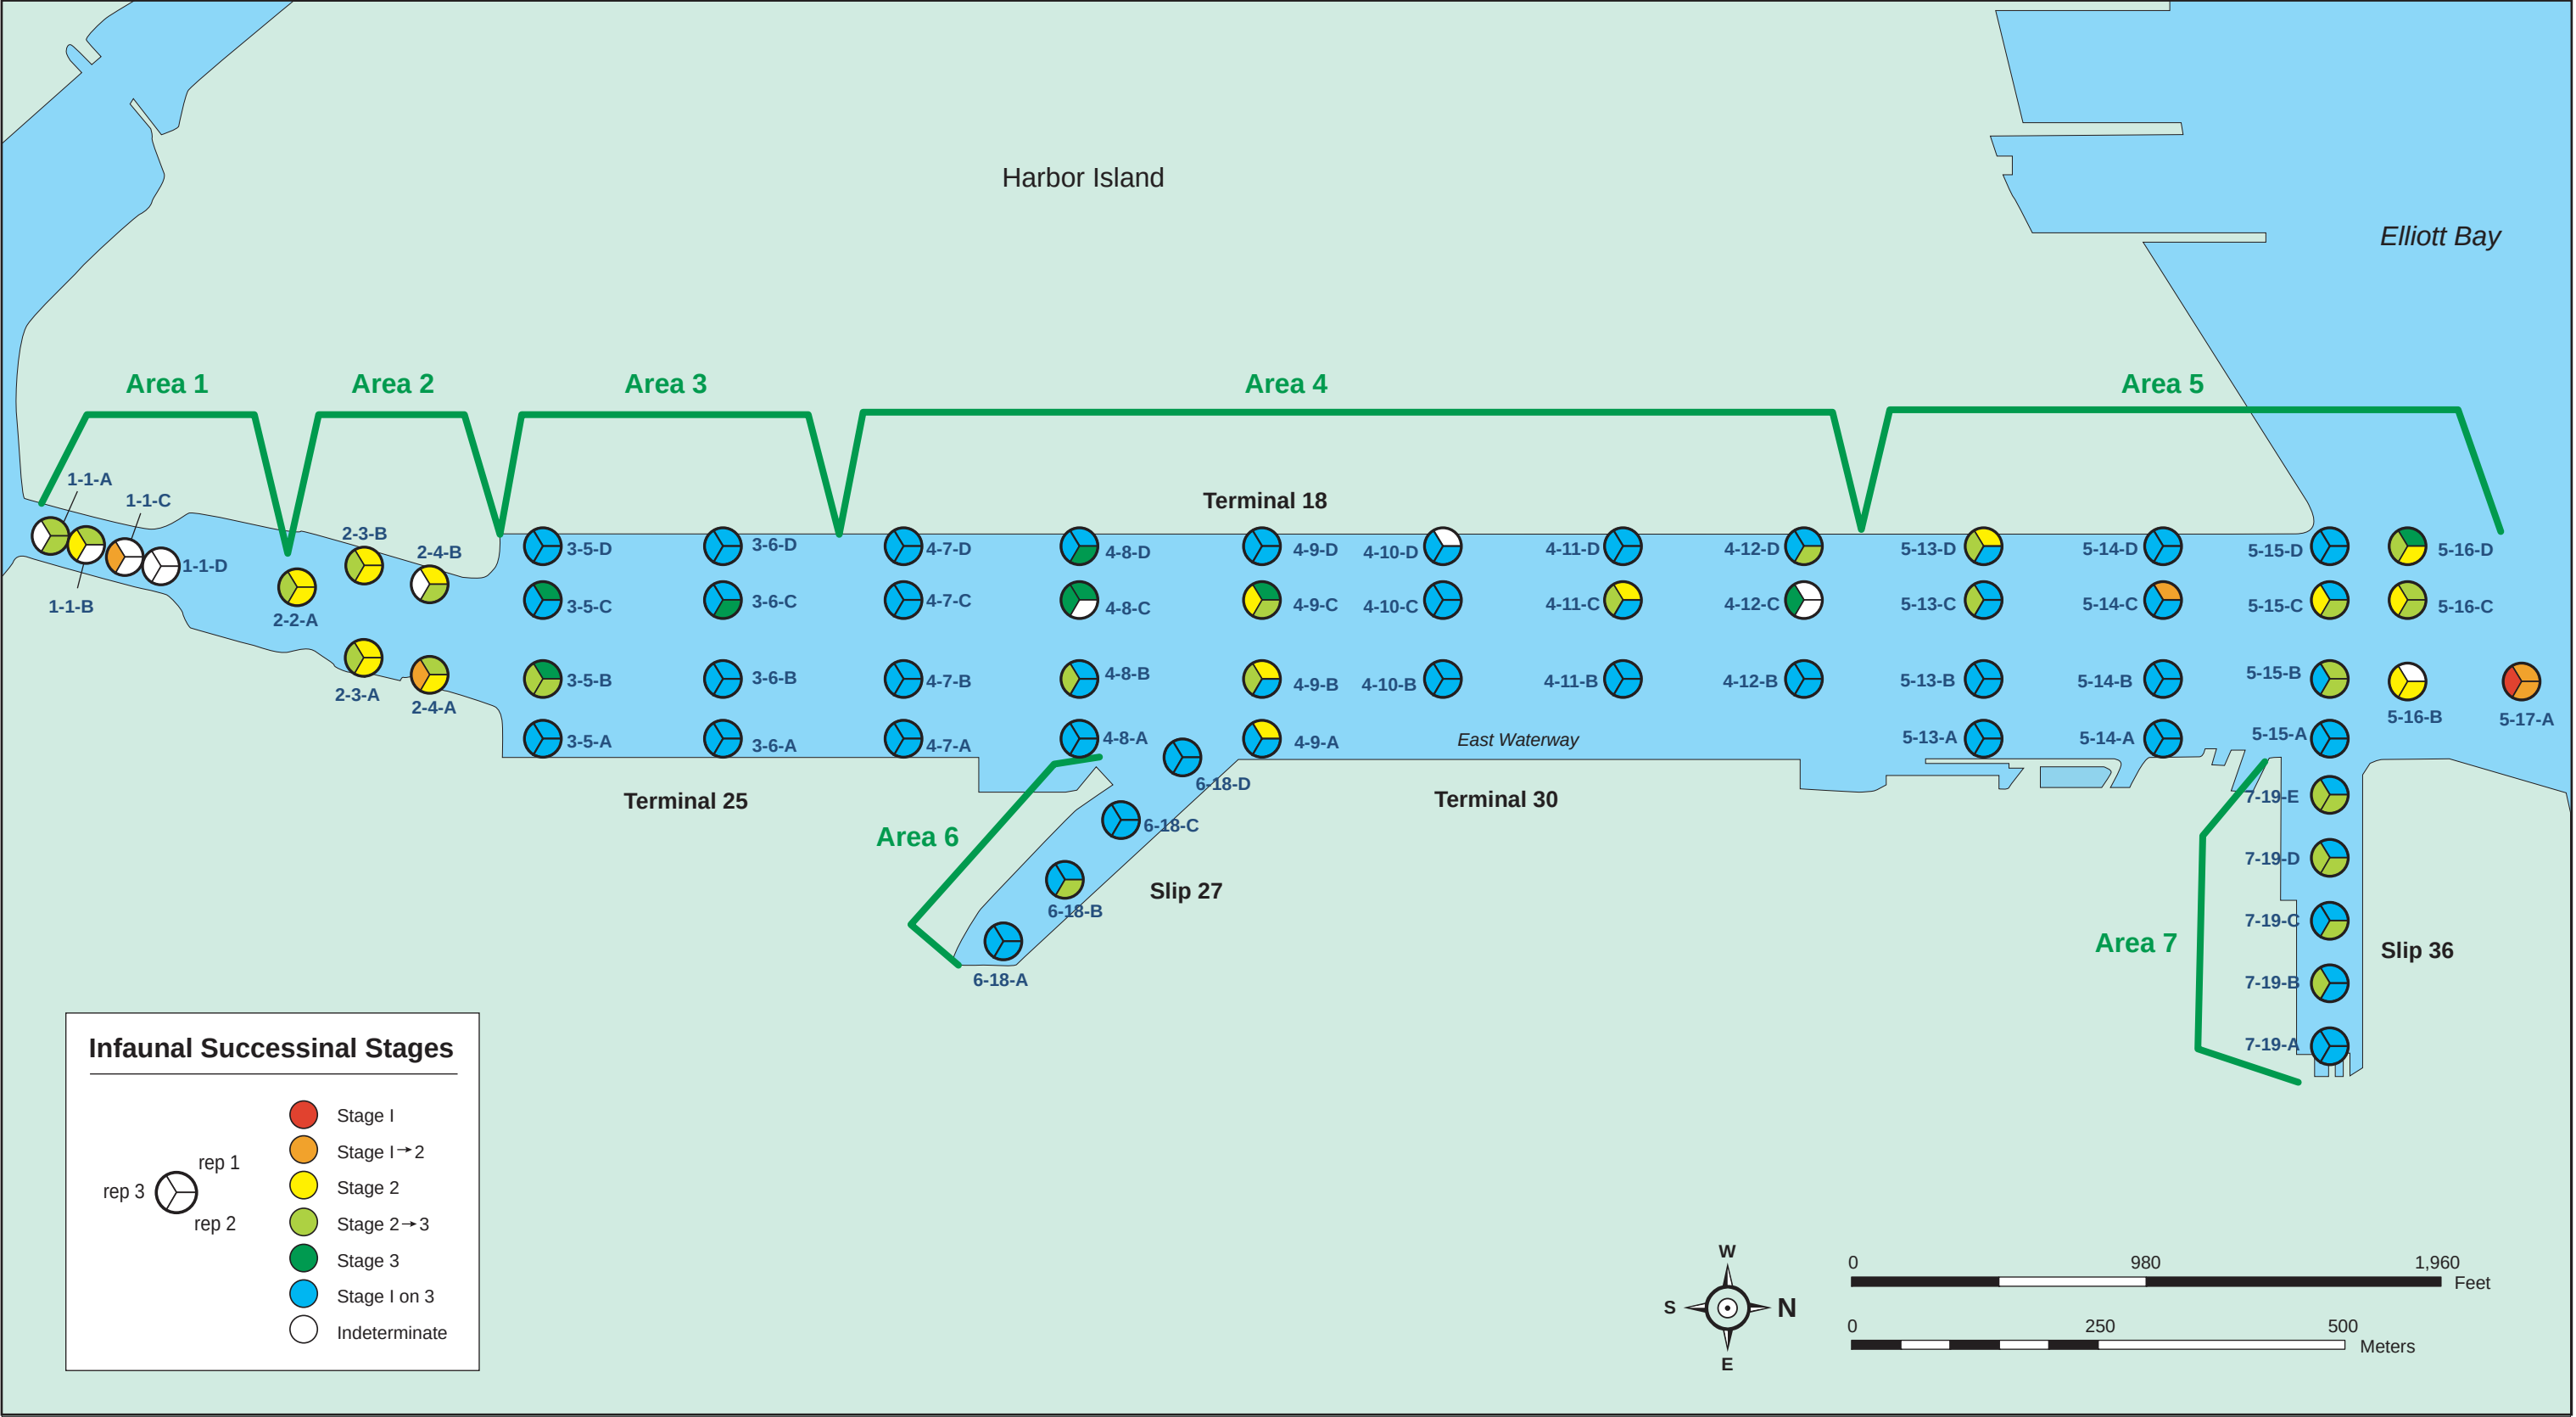
Source: Germano & Associates 2009, presented as Appendix G in Windward 2009a.

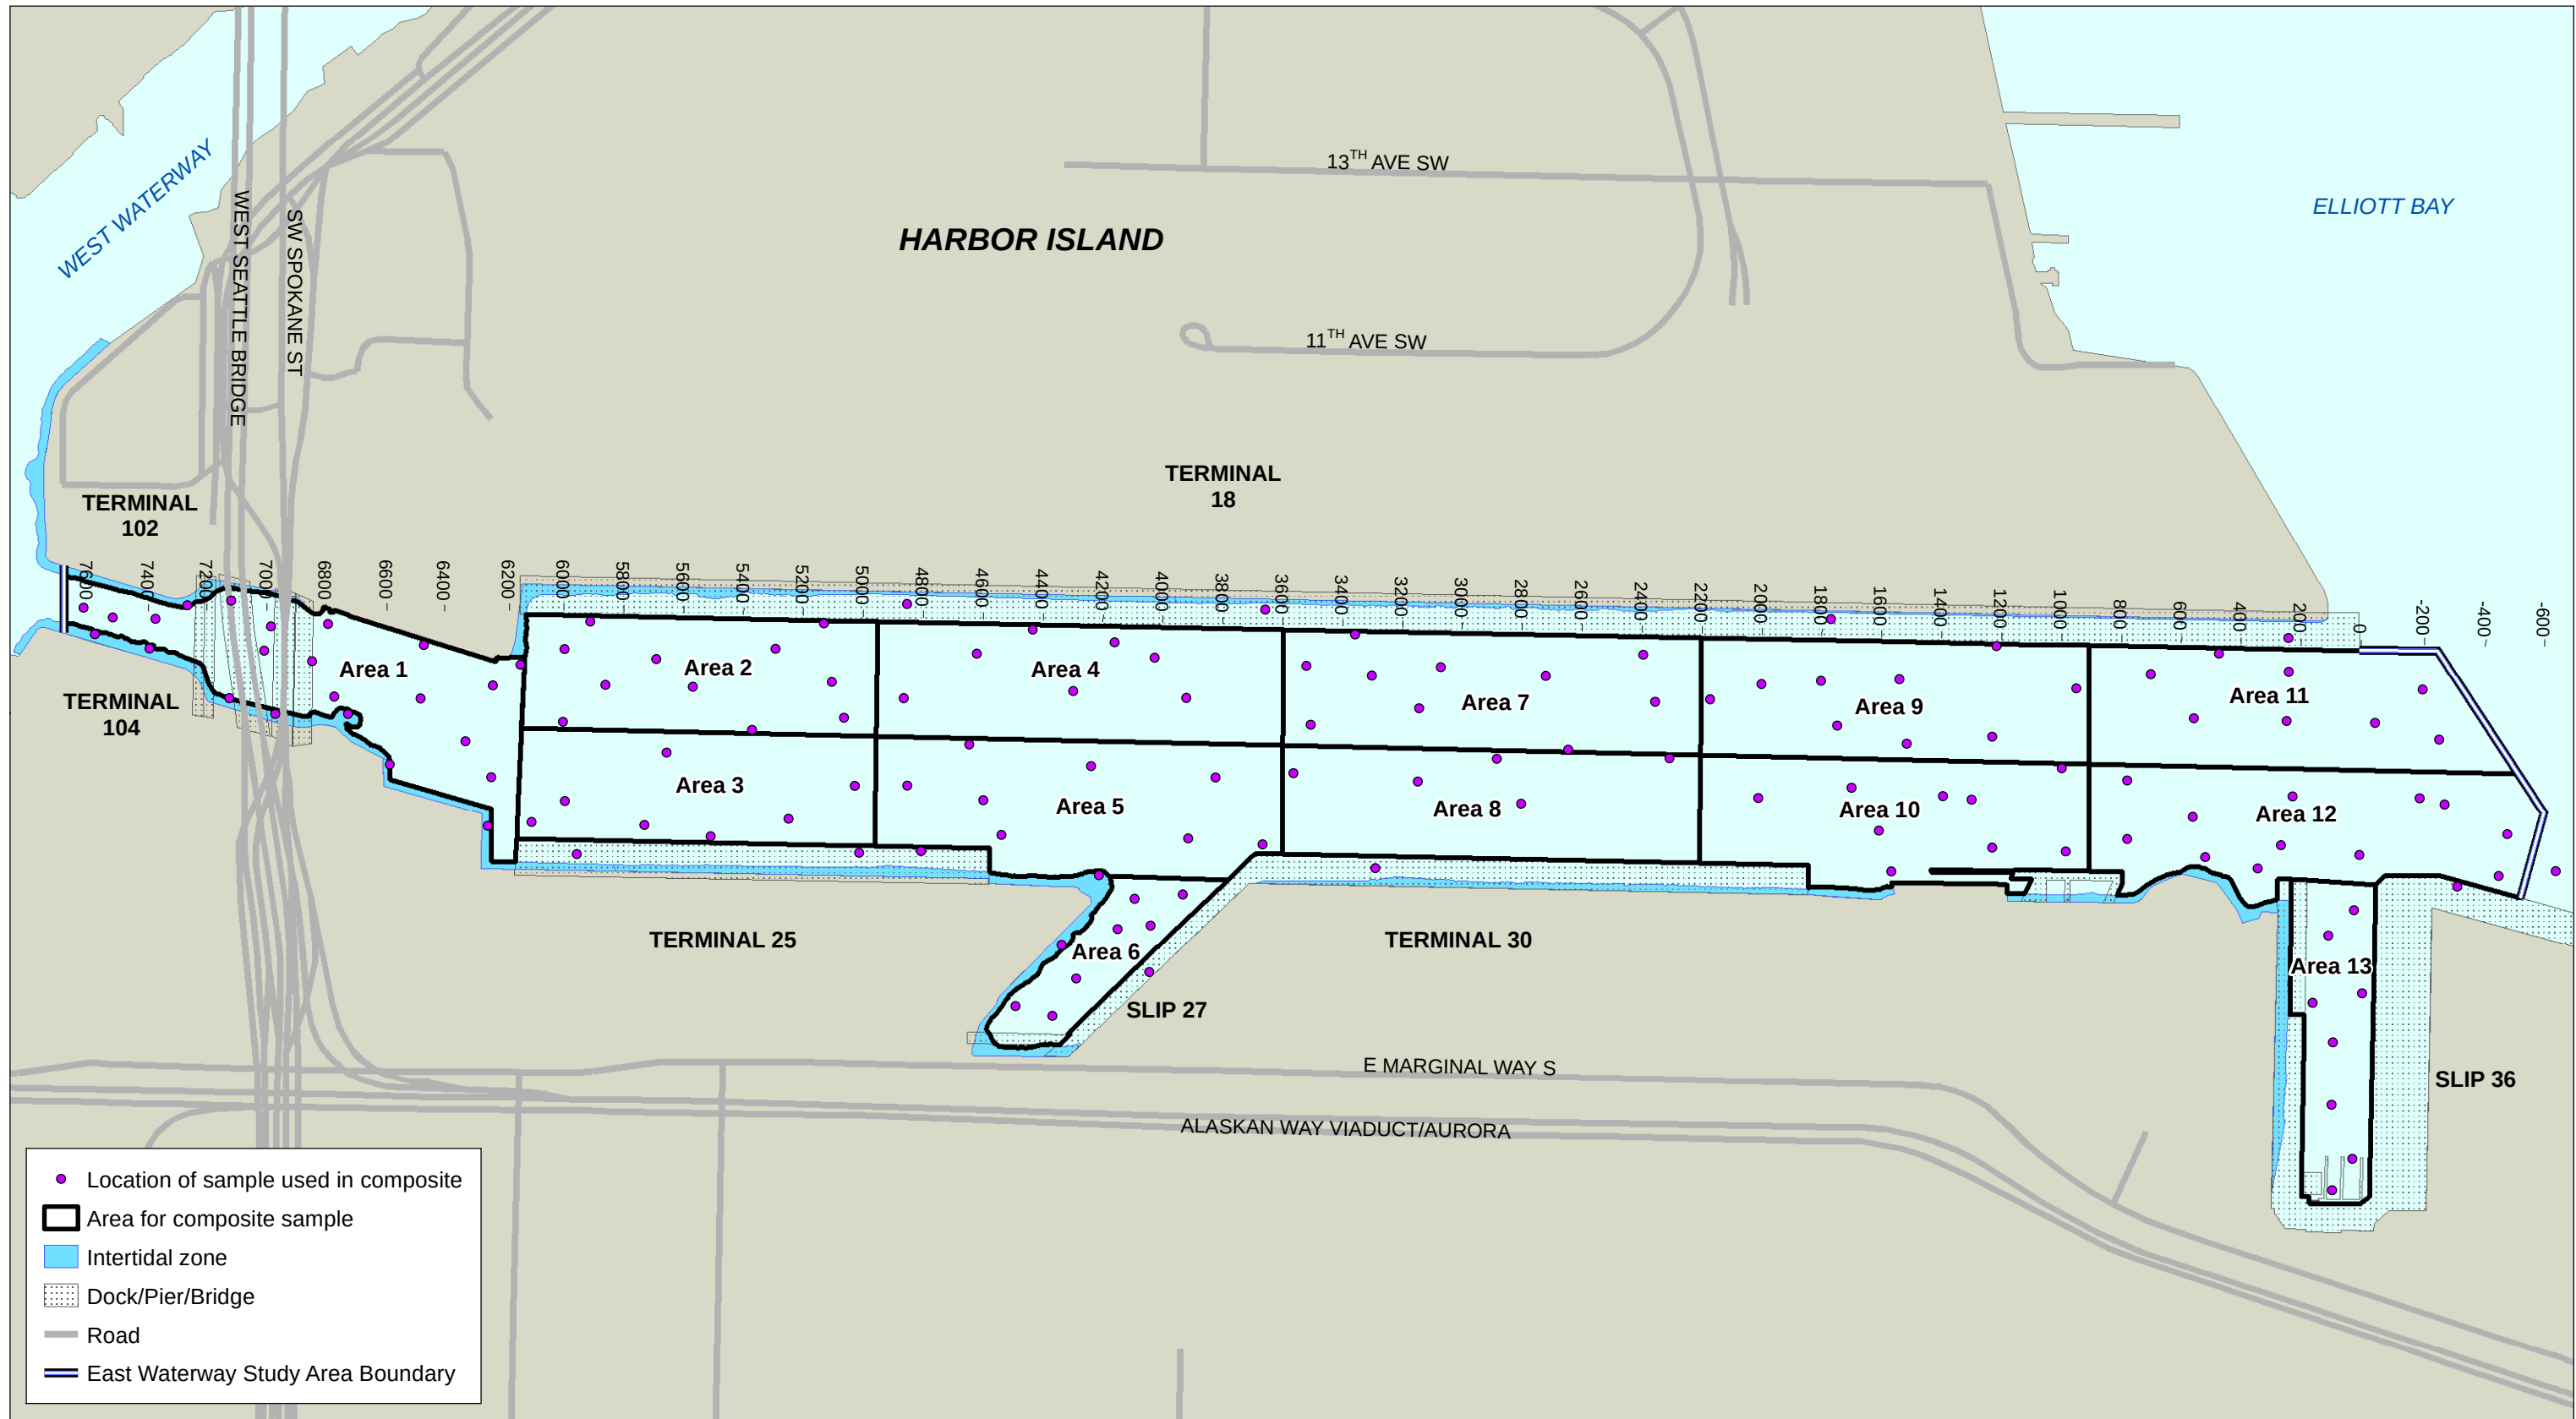
Map A.2-3. Sampling locations for composite surface sediment samples analyzed for PCB congeners and dioxins/furans

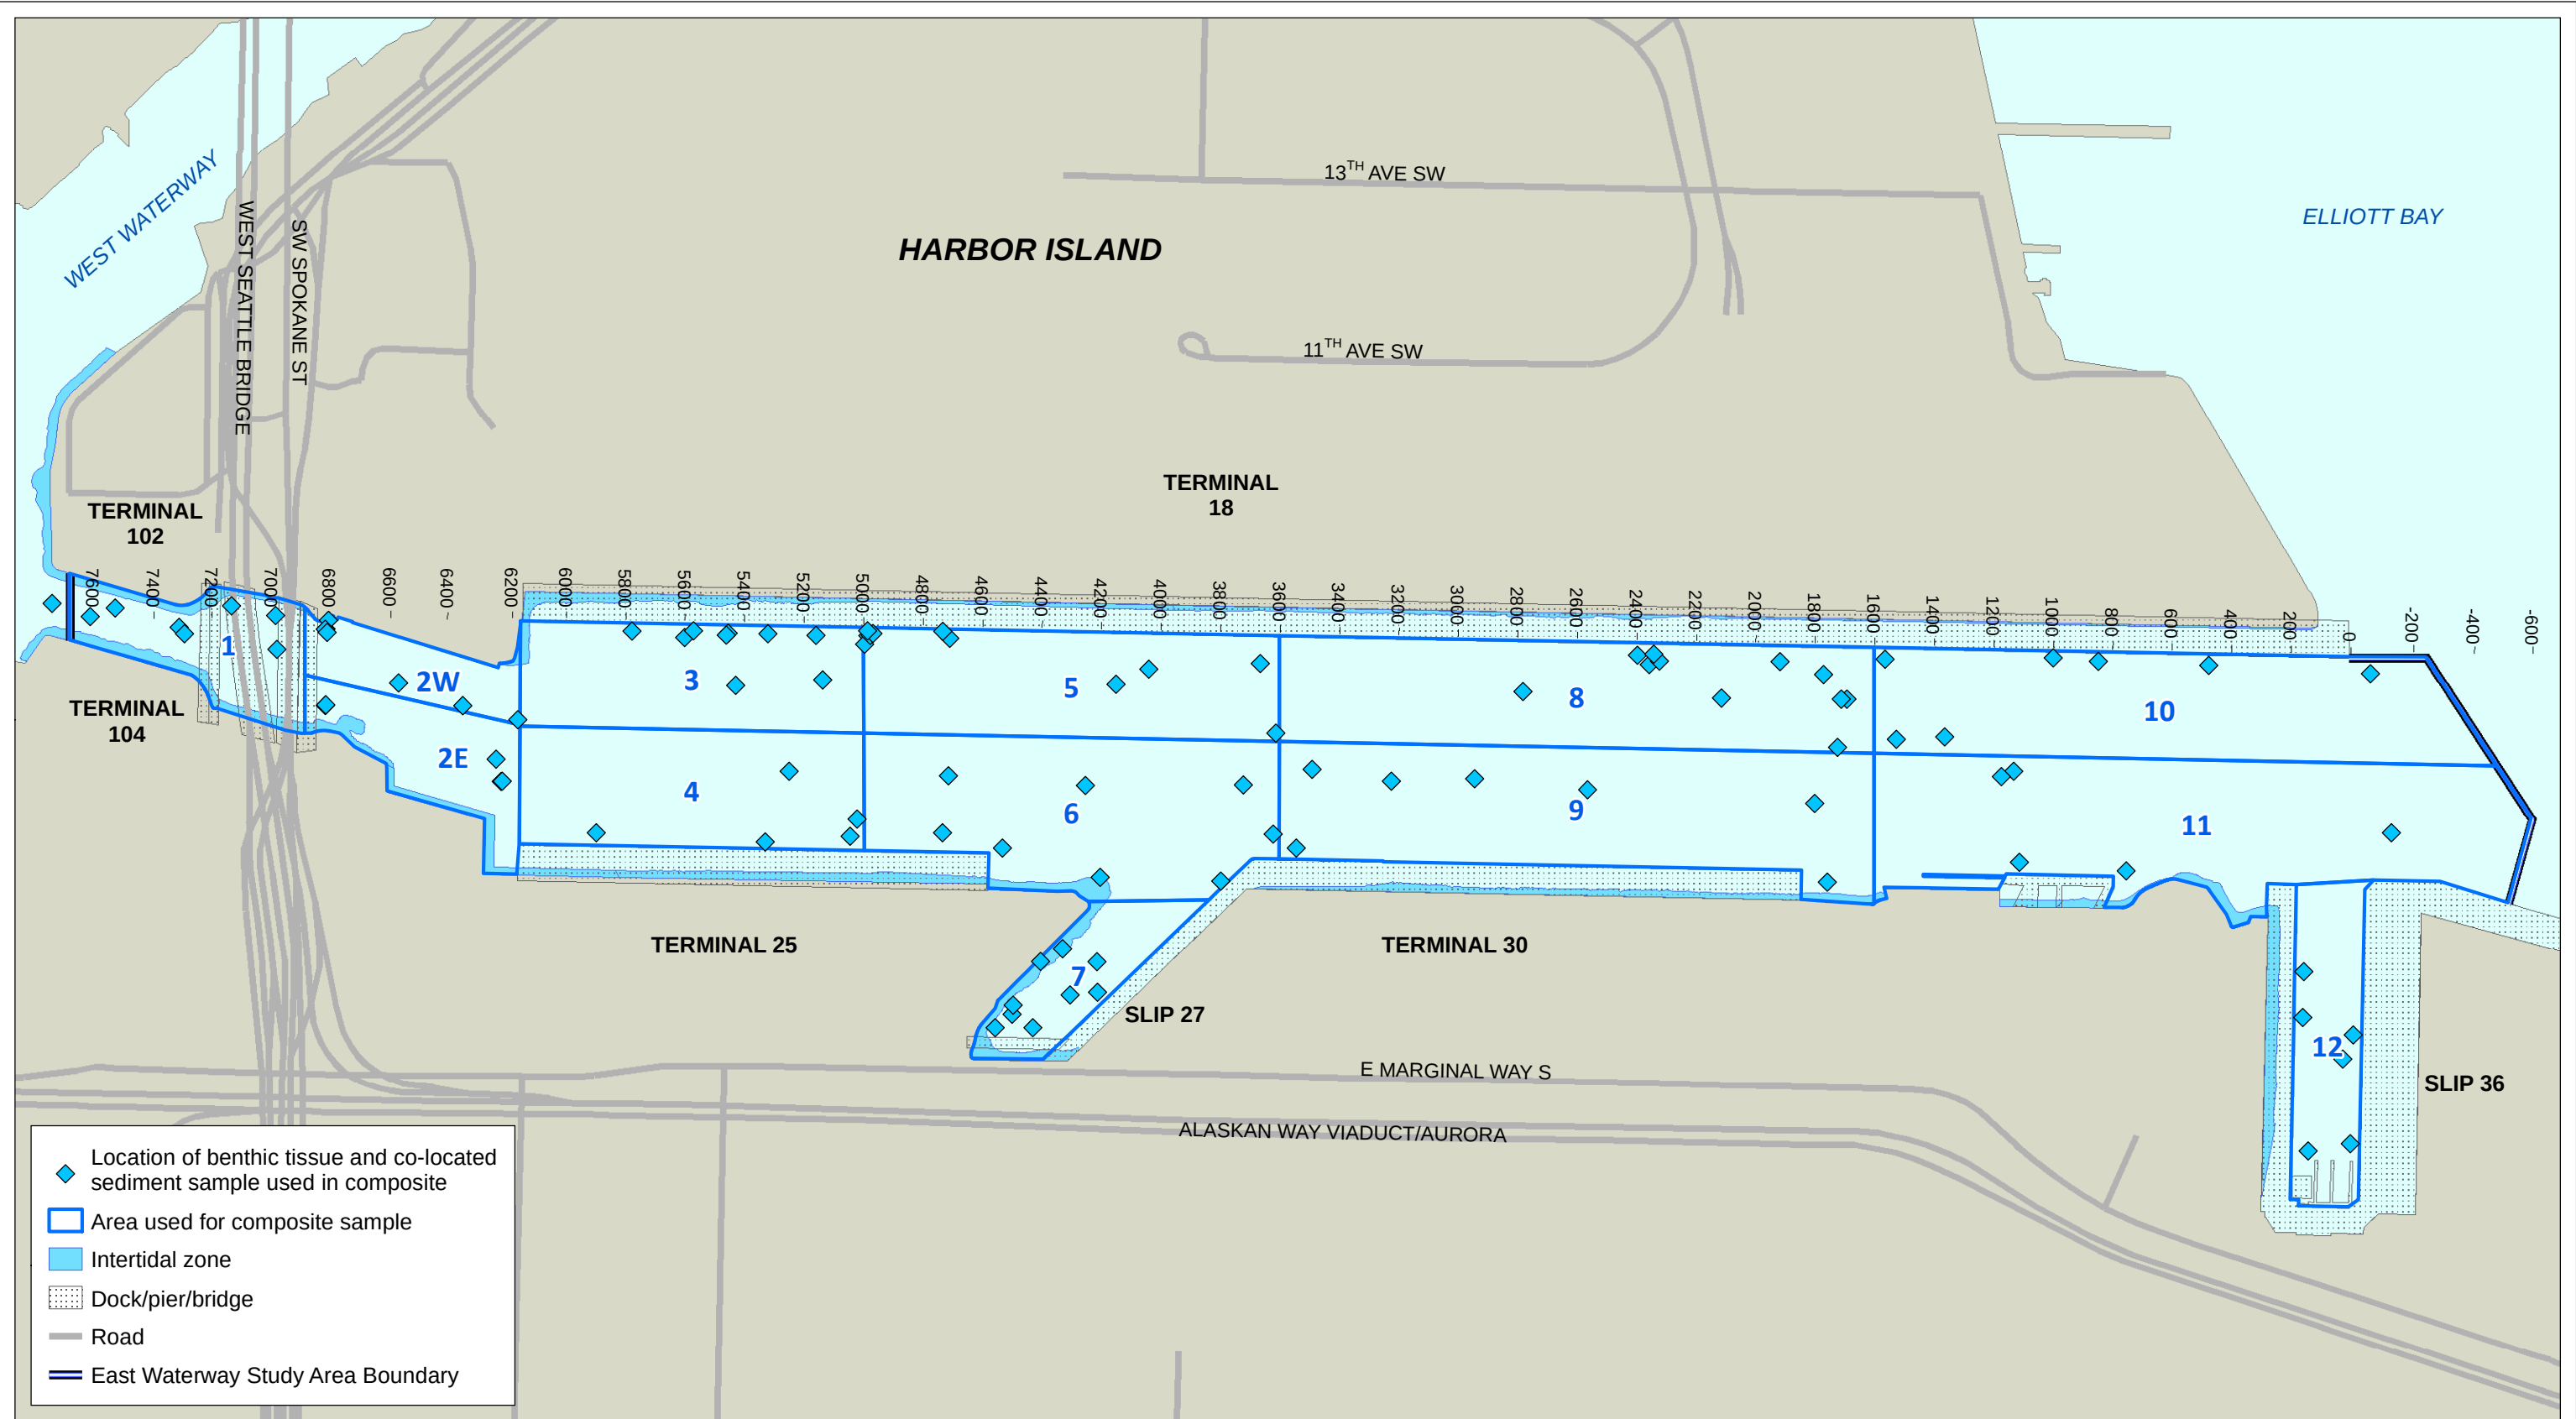
Map A.2-5. Sampling locations for PCBs and mercury in benthic invertebrate tissue

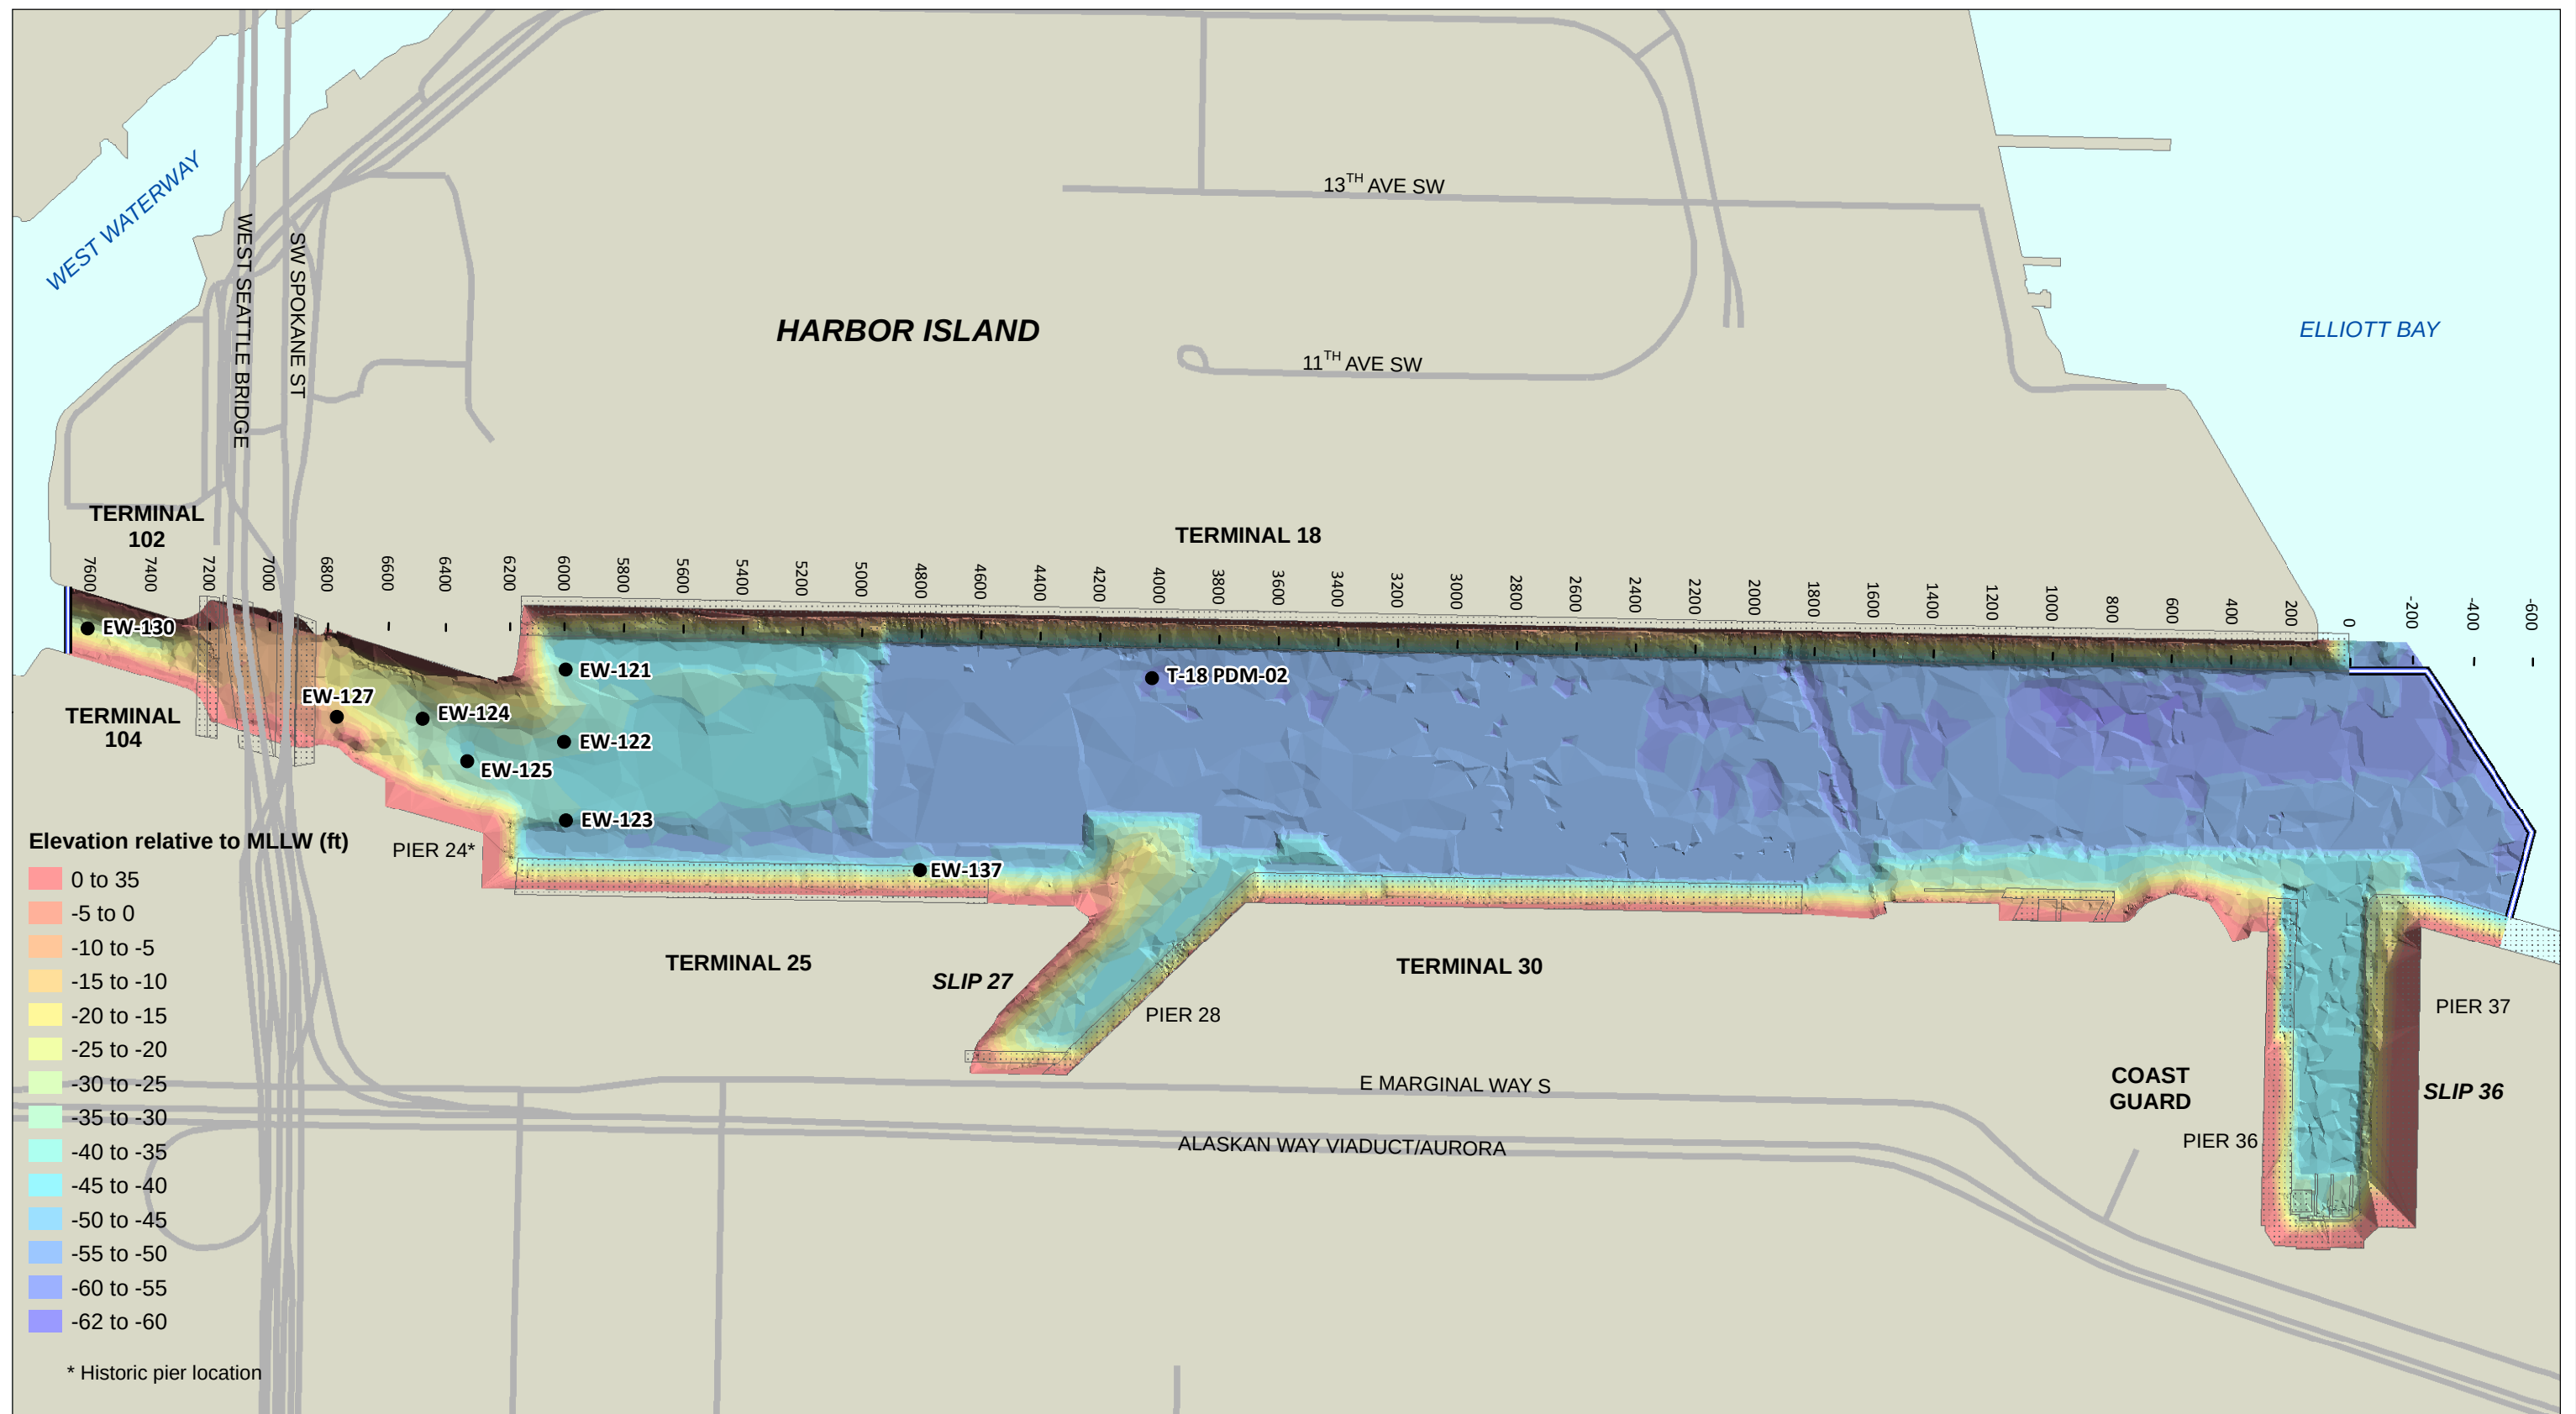
- Trumped bioassay location
- Road
- ▨ Dock/pier/bridge
- East Waterway Study Area Boundary

**Map A.2-8. Sample locations that were initially sampled for chemistry and bioassay, and re-sampled for chemistry only**

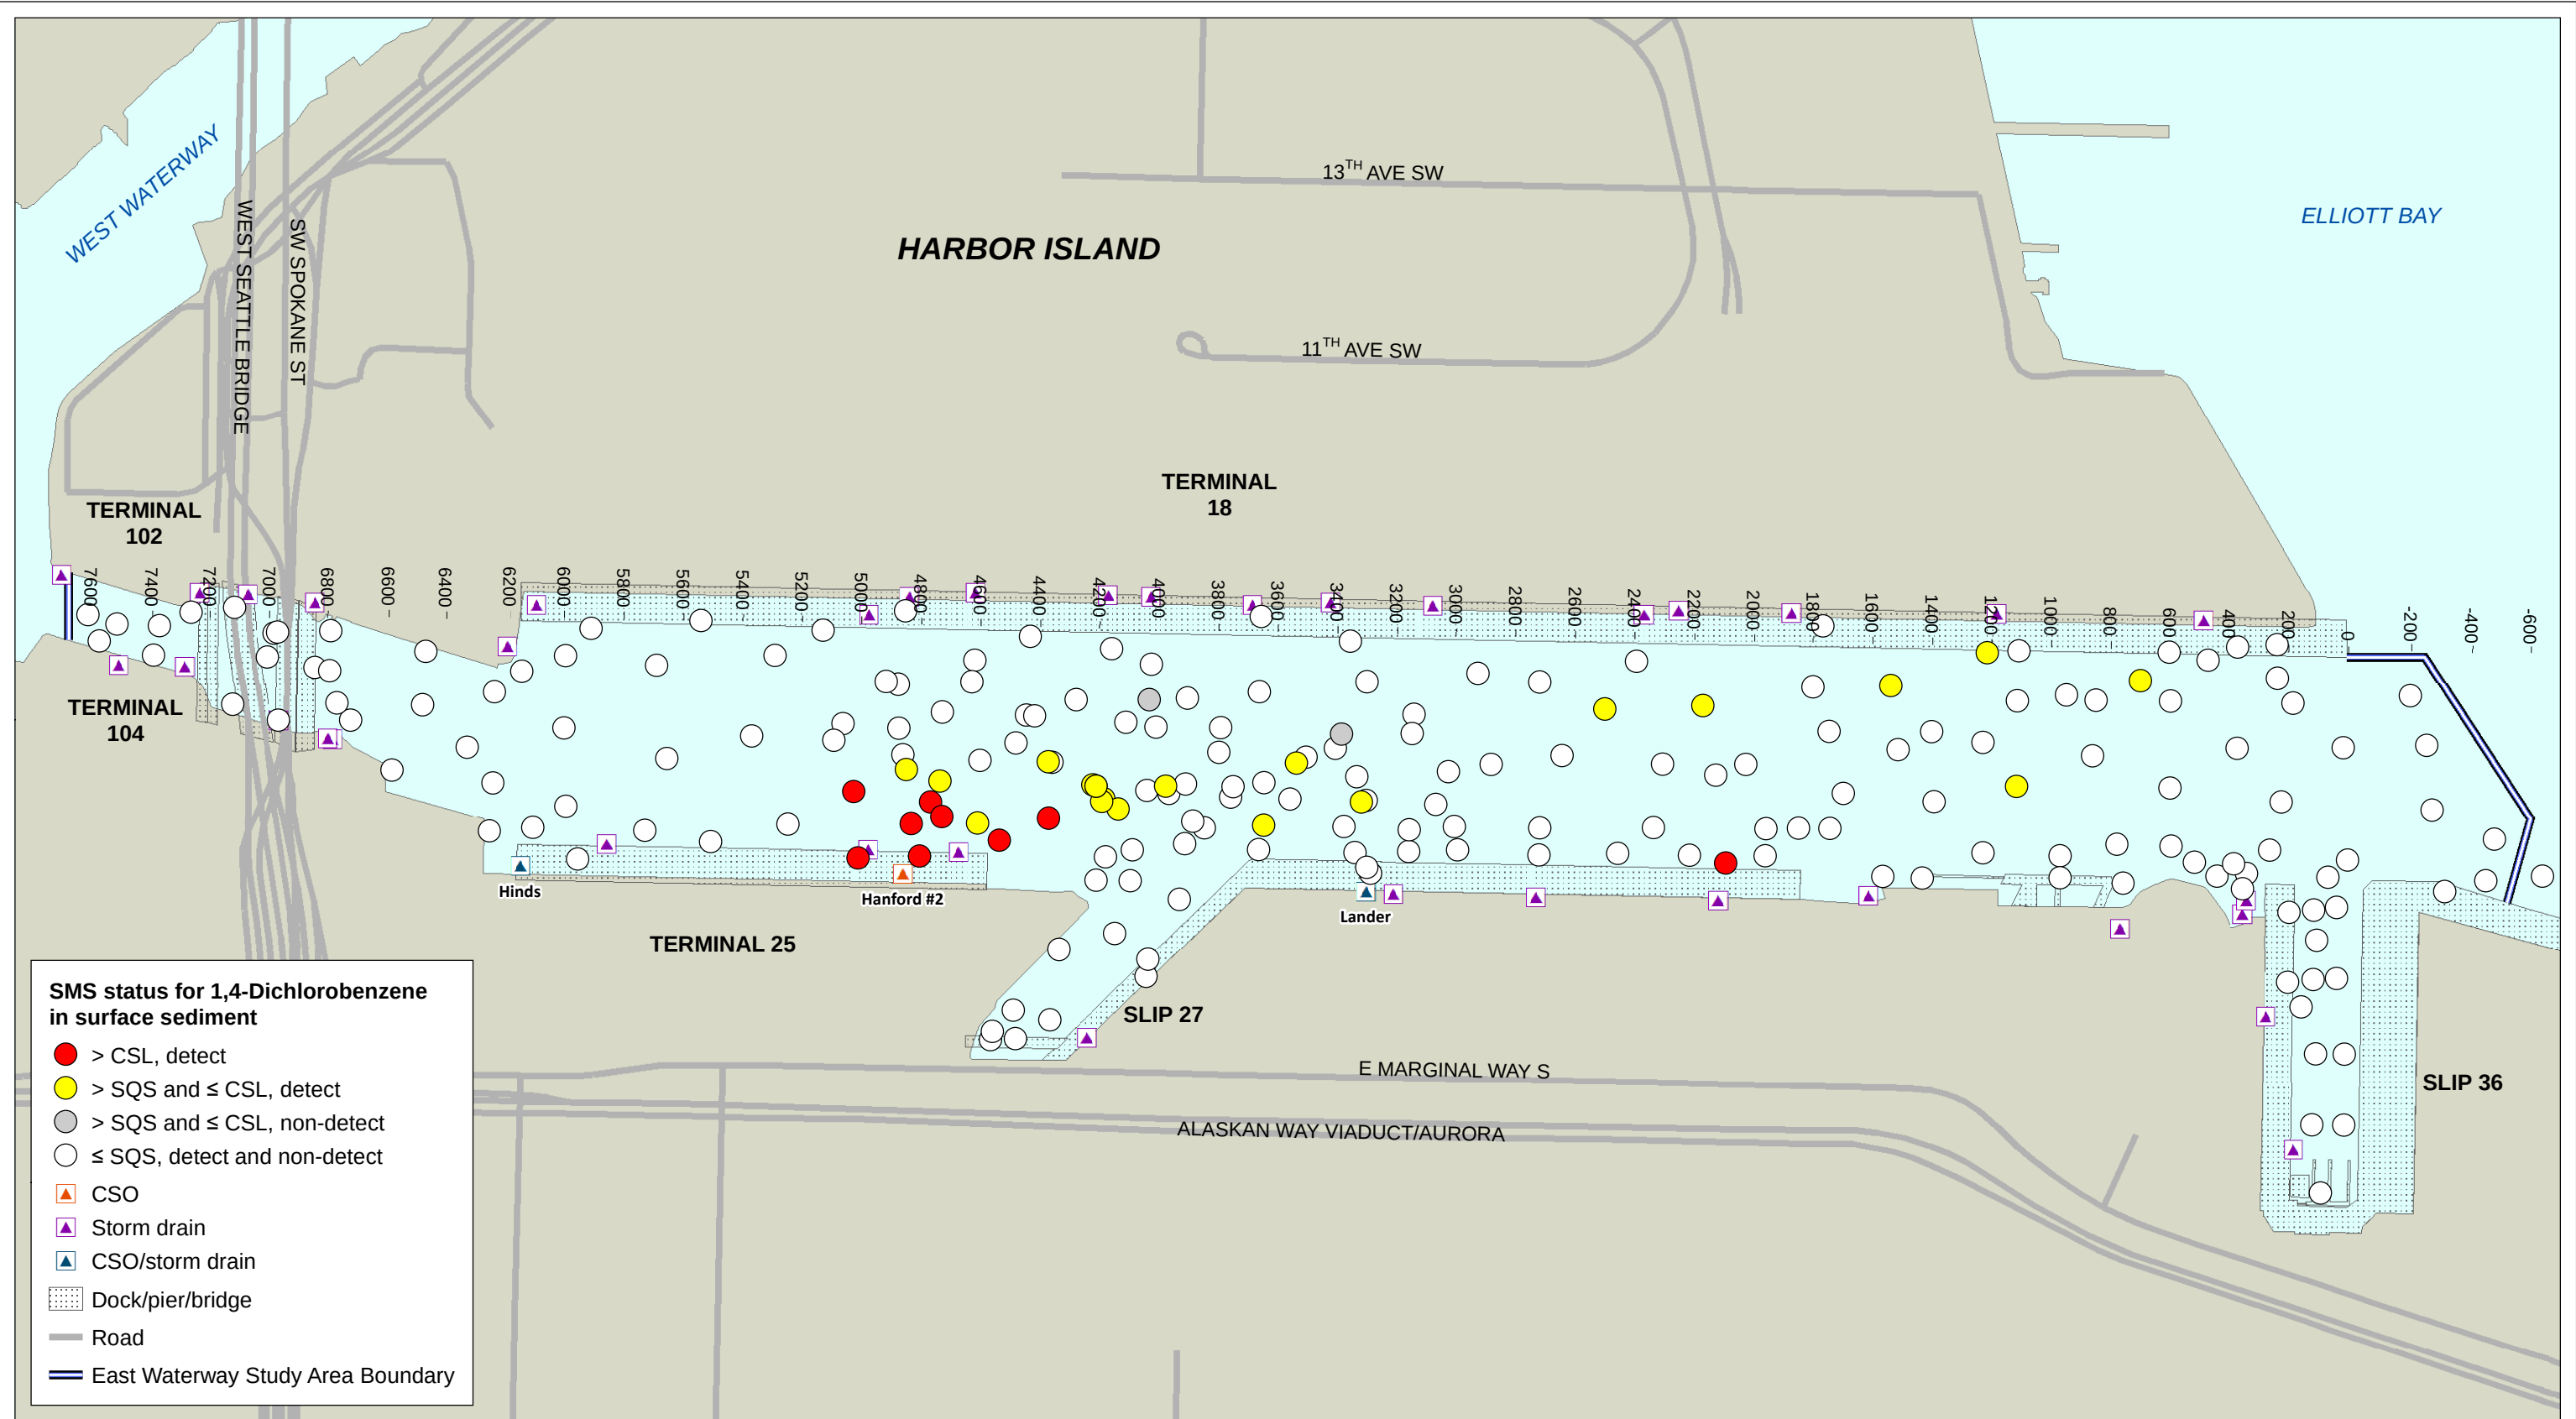
Map A.6-3. Exceedances of SMS criteria for 1,4-dichlorobenzene in surface sediment

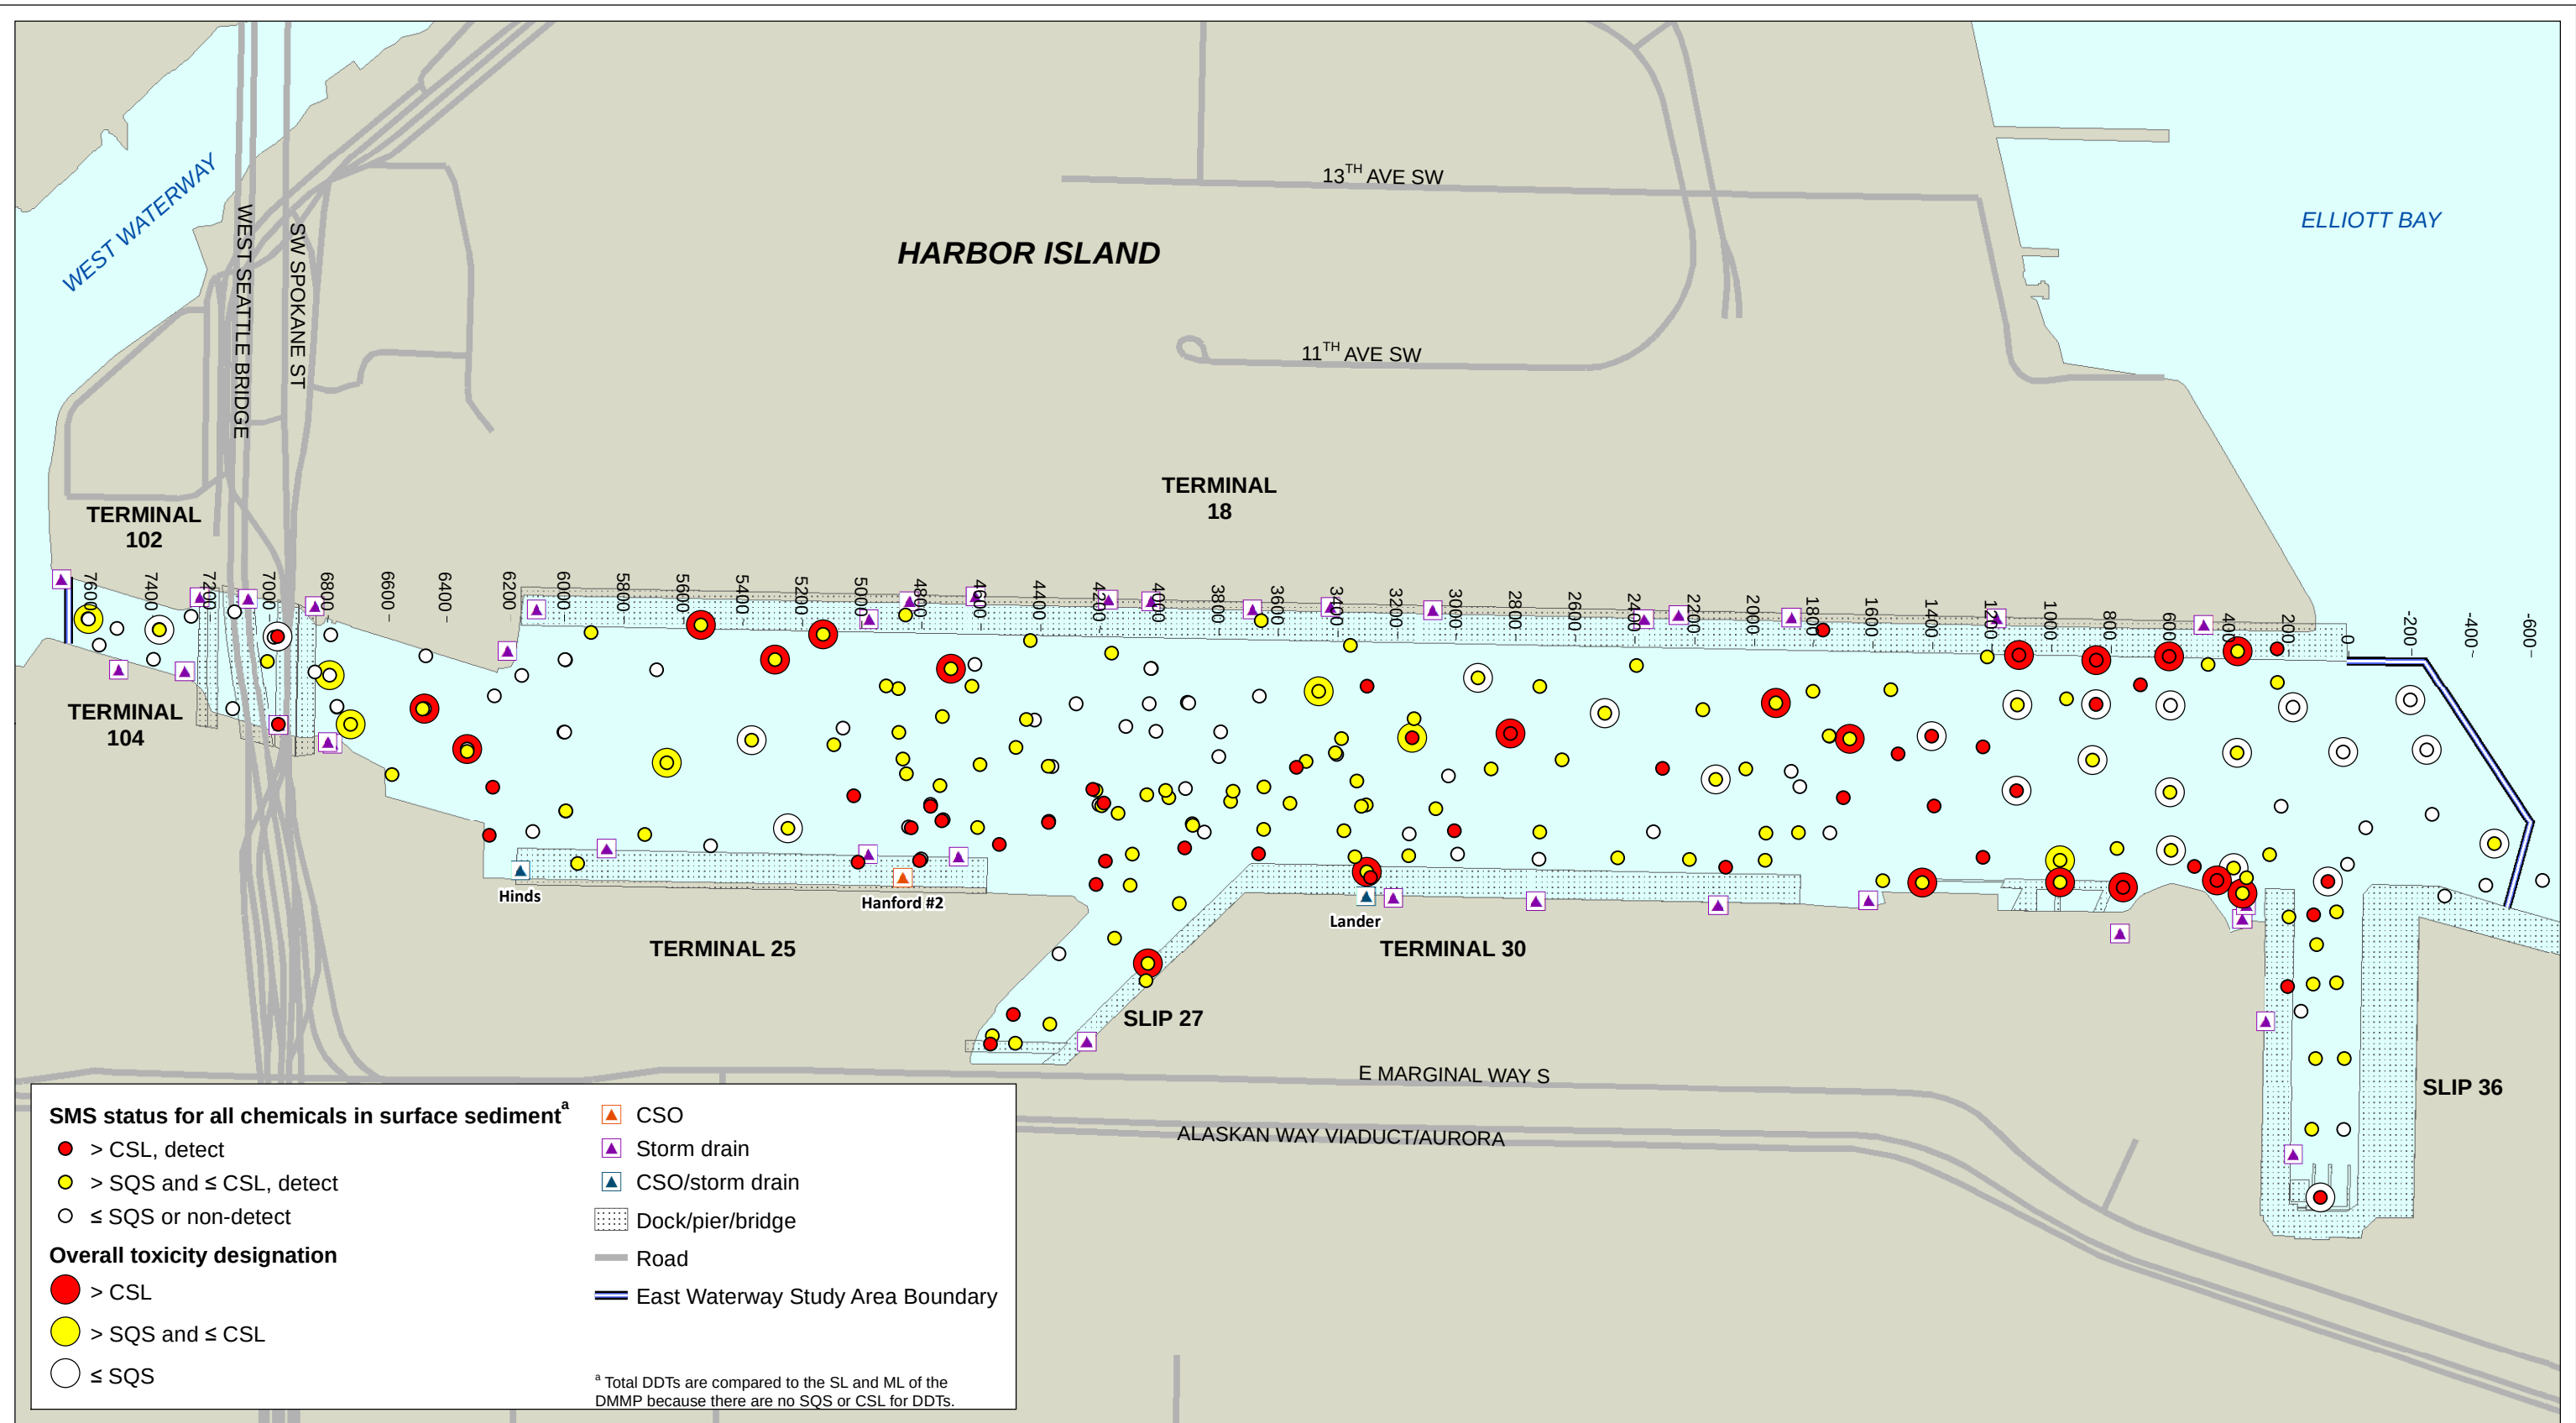
Map A.6-4. Exceedances of SMS (chemical and toxicity test results combined) for the baseline surface sediment dataset
