Map A.2-1. Spatial distribution of infaunal successional stages in the EW.

Map A.2-2. Sampling locations for discrete surface sediment samples and bioassay data used in the ERA

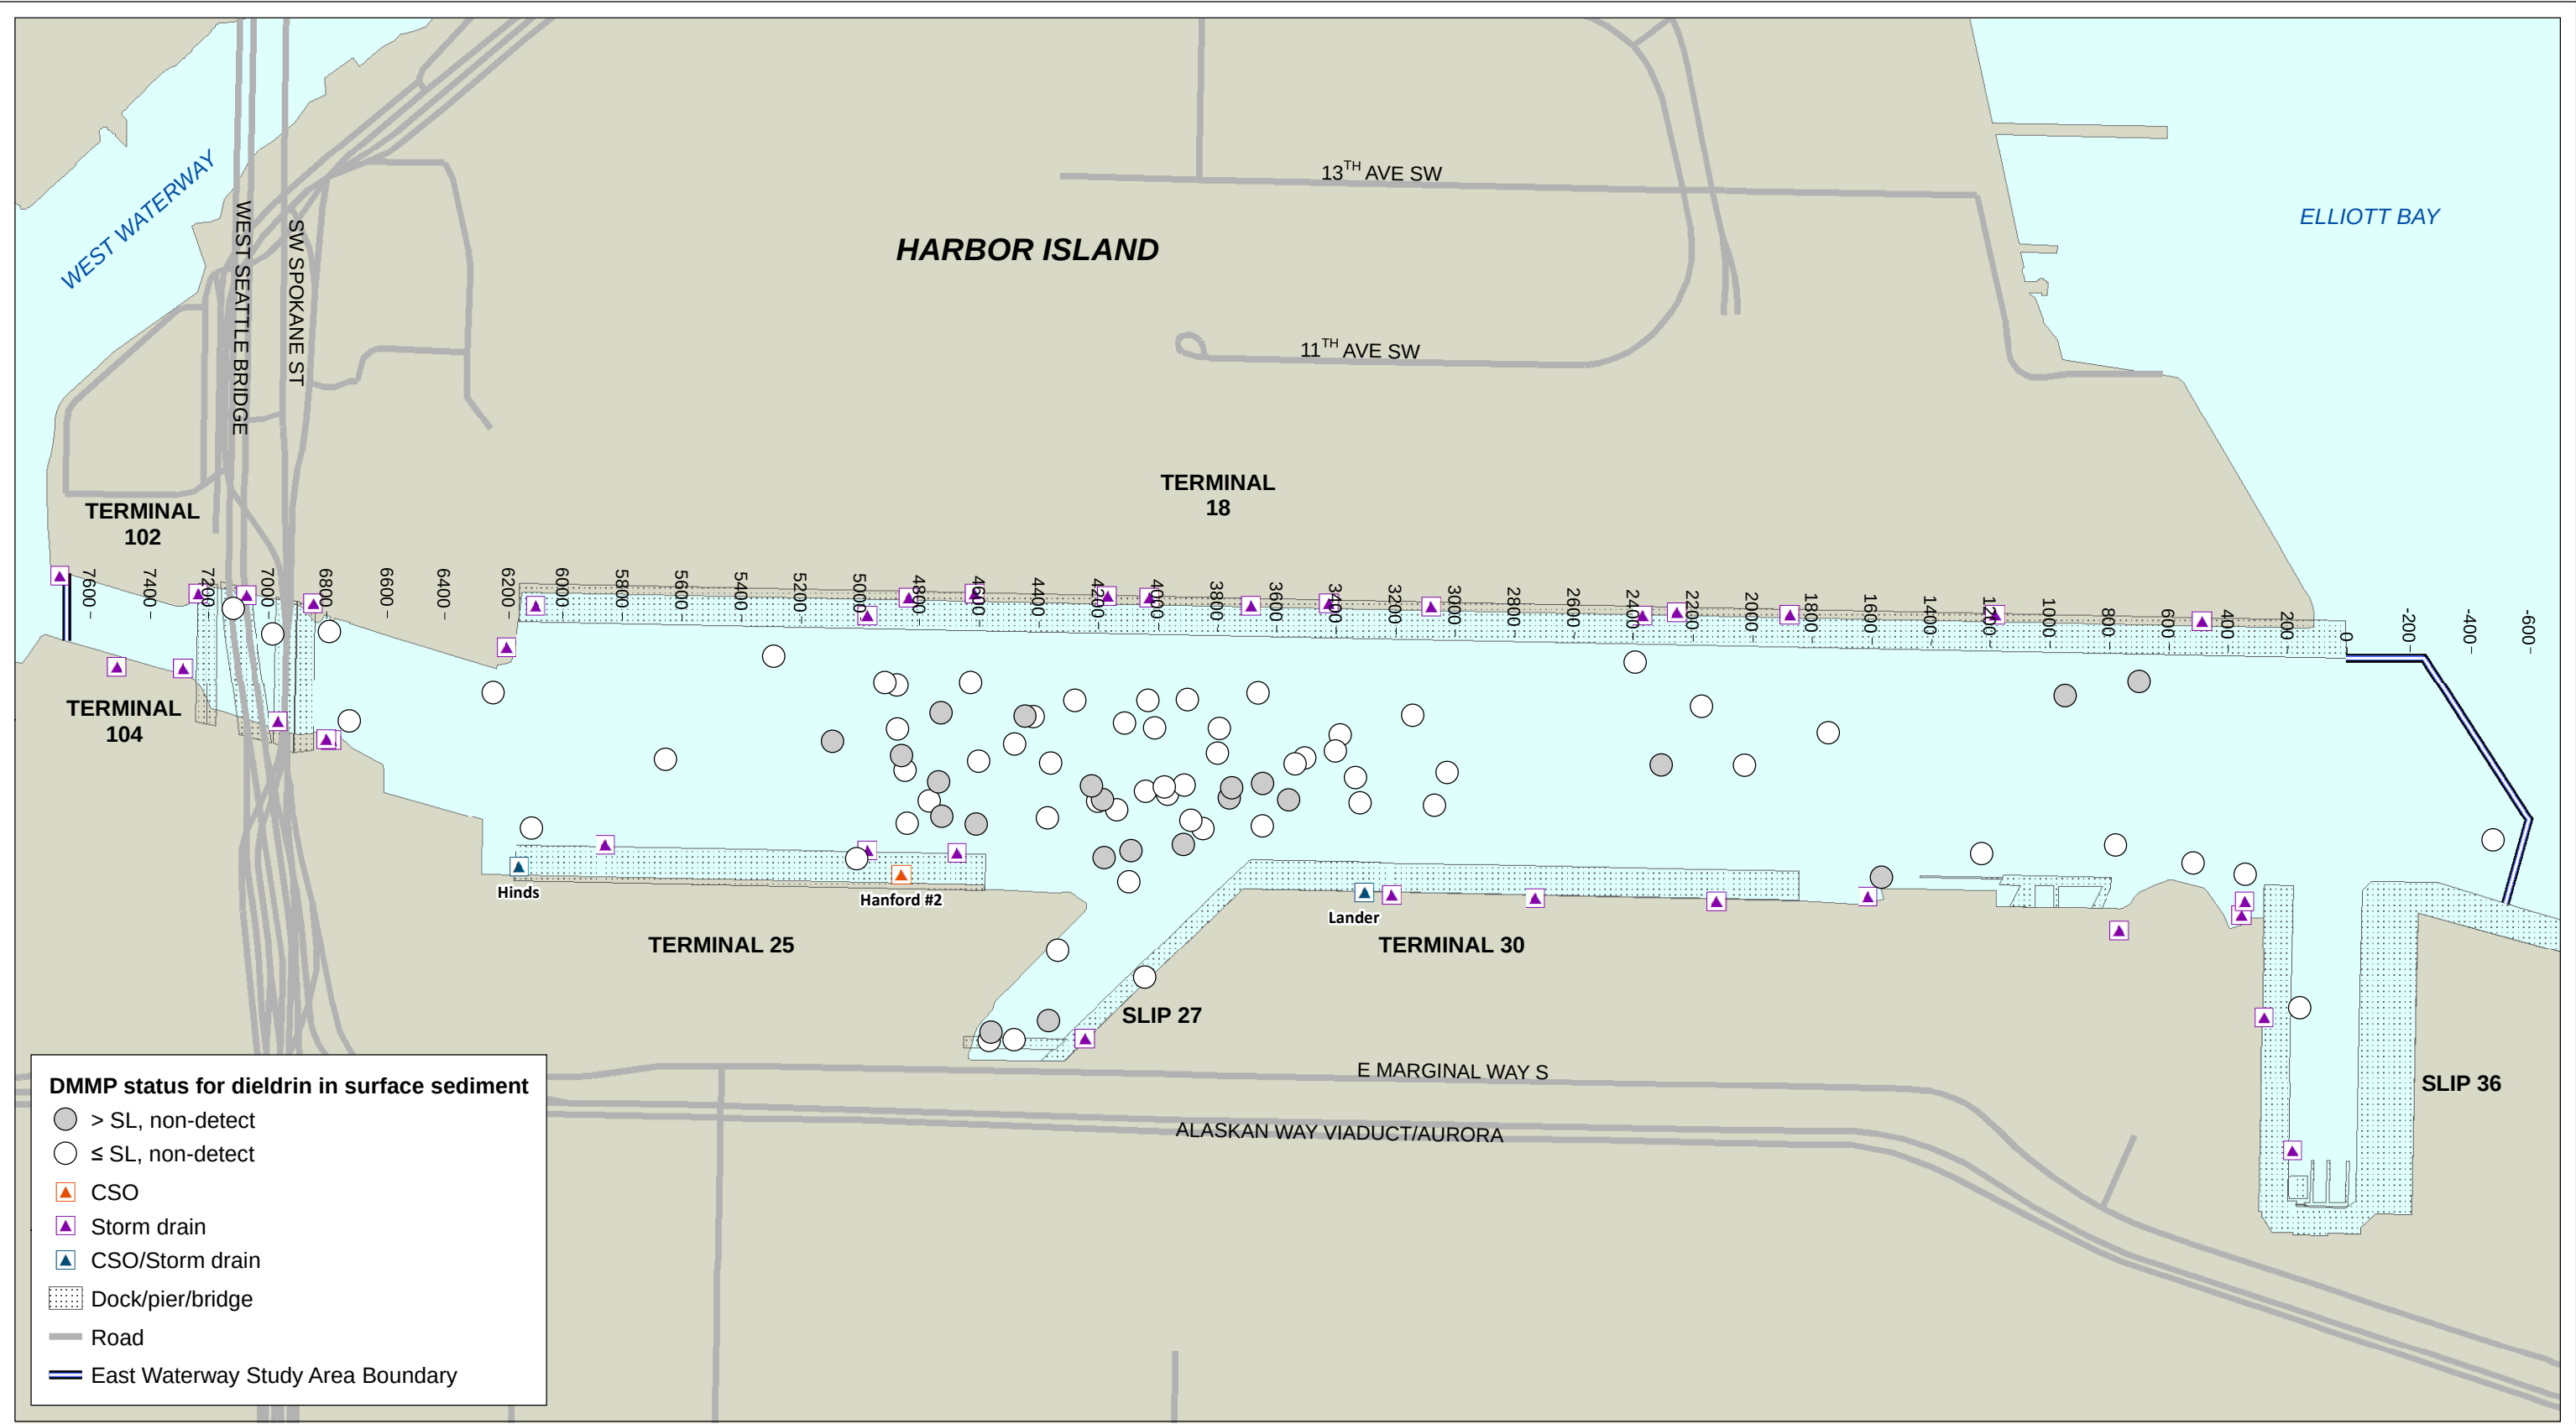
Map A.6-10. Exceedances of SL or ML for dieldrin in surface sediment
